Access Compliance Report

Public Rights-of-Way

(Curb Ramps)

Intersection ID: 16415	Main Street: BEVERLY_DR	Cross Street: SHERWOOD_AV	Location: W
ADA ID: 76D01BB30AE0	Ramp Type: PerpDiag	Initial Pass/Fail: Fail	Overall Compliance: No
Codes/Mitigation Info/Possible Solution		Field Measurements/Component Compliance

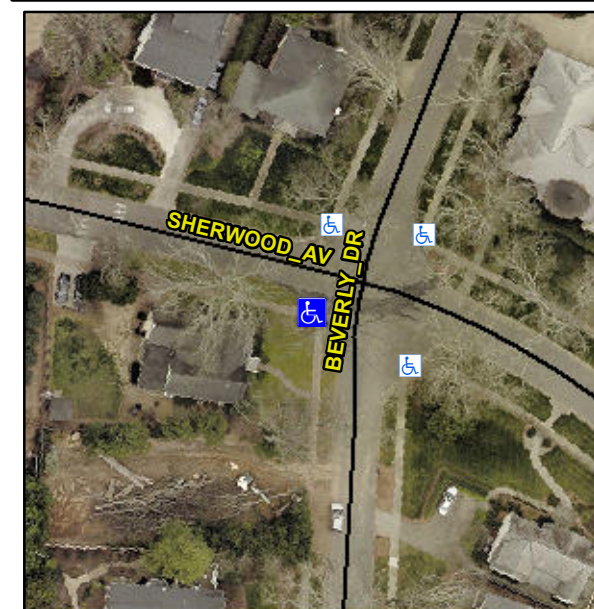
Not Found, R304.2.2, R304.5.3

Compliance	Description	Data	Compliance	Description	Data
N/A	Ramp Length (in)	38.0	No	Ramp Slope (%)	14.5
Yes	Ramp Width (in)	48.0	No	Ramp XSlope (%)	3.9
N/A	Flare Type LT	N/A	N/A	Flare Type RT	N/A
N/A	Flare Slope LT (%)	N/A	N/A	Flare Slope RT (%)	N/A
N/A	Flare Traversable LT?	N/A	N/A	Flare Traversable RT?	N/A
N/A	Landing Length (in)	N/A	N/A	DWS Provided?	N/A
N/A	Landing Width (in)	N/A	N/A	DWS Contrast?	N/A
N/A	Landing Slope (%)	N/A	N/A	DWS Length (in)	N/A
N/A	Landing X Slope (%)	N/A	N/A	DWS Full Width?	N/A
N/A	Landing Curb? (Y/N)	N/A	N/A	DWS Offset (in)	N/A
N/A	Shared Landing?	N/A			
N/A	Gutter Ponding?	N/A	N/A	Gutter Slope (%)	N/A
N/A	Gutter Lip Ht (in)	N/A	N/A	Gutter X Slope (%)	N/A
N/A	Painted X Walk1?	No	N/A	Painted X Walk2?	No
	X Walk 1 Direction	To SE		X Walk 2 Direction	To NE
N/A	X Walk 1 Width (in)	N/A	N/A	X Walk 2 Width (in)	N/A
	X Walk 1 Slope (%)	0.6		X Walk 2 Slope (%)	1.2
	X Walk 1 X Slope (%)	0.9		X Walk 2 X Slope (%)	1.3

N/A	Ramp inside XWalk1?	N/A	N/A	Ramp inside XWalk2?	N/A
	Road Slope (%)	1.0	N/A	Clear Space?	N/A
	Road X Slope (%)	0.8	N/A	Clear Space to XWalk (in)	N/A
N/A	Any Obstructions?	N/A	N/A	Storm Grate/Utility Hazard?	N/A
	Obstruction Type			Storm Grate/Utility Type	
		N/A			N/A
			Yes	Surface Condition? (G/P)	Good

Possible Solutions:

Remove & Replace Curb Ramp With Two New Directional Ramps or Equivalent.
