# Access Compliance Report

## Public Rights-of-Way

### (Curb Ramps)

| Intersection ID: 6318 | Main Street: FRANKLIN_THOMAS_PL | Cross Street: JORDANS_POND_LN | Location: | N/A |

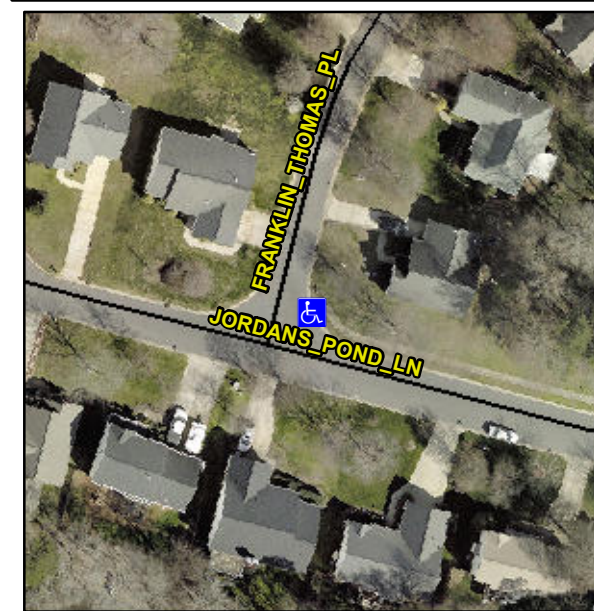
| ADA ID: 76D4203F675F | Ramp Type: Perp | Initial Pass/Fail: Fail | Overall Compliance: No | Severity Score: 10 |

**Not Found, R304.5.1, R304.5.3**

| Compliance | Description | Data | Compliance | Description | Data |
|---|---|---|---|---|---|
| No | Ramp Width (in) | 47.0 | No | Ramp XSlope (%) | 2.7 |

**Remove & Replace Entire Ramp.**

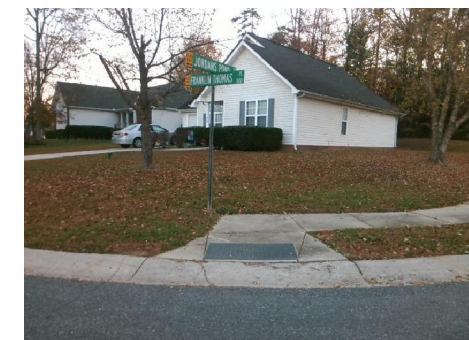
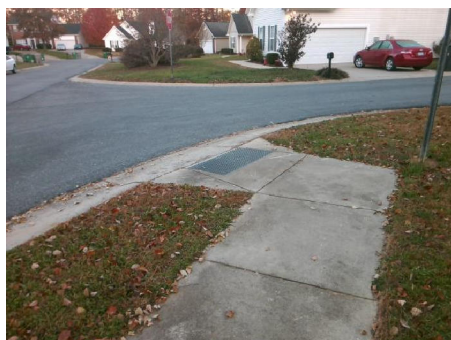
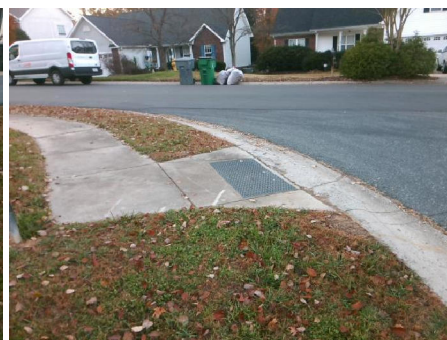
| Compliance | Description | Data | Compliance | Description | Data |
|---|---|---|---|---|---|
| N/A | Ramp Length (in) | 46.0 | Yes | Ramp Slope (%) | 5.8 |
