Access Compliance Report

Public Rights-of-Way

(Curb Ramps)

Intersection ID: 50613	Main Street: BALSAM_BAY_RD	Cross Street: DOWNY_BIRCH_RD	Location: E
ADA ID: 76D8EA4DA61B	Ramp Type: Perp	Initial Pass/Fail: Fail	Overall Compliance: No
Severity Score: 33.75			
Codes/Mitigation Info/Possible Solution		Field Measurements/Component Compliance

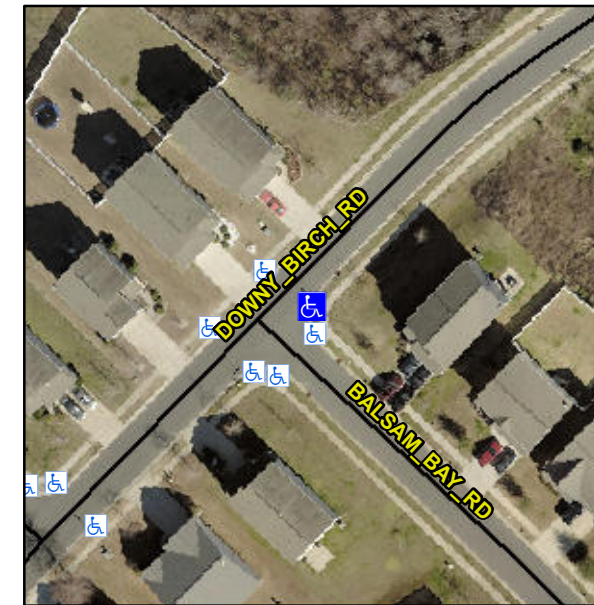
Compliance	Description	Data	Compliance	Description	Data
N/A	Ramp Length (in)	48.0	Yes	Ramp Slope (%)	8.1
No	Ramp Width (in)	46.5	No	Ramp XSlope (%)	7.0
N/A	Flare Type LT	N/A	N/A	Flare Type RT	N/A
N/A	Flare Slope LT (%)	N/A	N/A	Flare Slope RT (%)	N/A
N/A	Flare Traversable LT?	N/A	N/A	Flare Traversable RT?	N/A
N/A	Landing Length (in)	N/A	N/A	DWS Provided?	N/A
N/A	Landing Width (in)	N/A	N/A	DWS Contrast?	N/A
N/A	Landing Slope (%)	N/A	N/A	DWS Length (in)	N/A
N/A	Landing X Slope (%)	N/A	N/A	DWS Full Width?	N/A
N/A	Landing Curb? (Y/N)	N/A	N/A	DWS Offset (in)	N/A
N/A	Shared Landing?	N/A			
N/A	Gutter Ponding?	N/A	N/A	Gutter Slope (%)	N/A
N/A	Gutter Lip Ht (in)	N/A	N/A	Gutter X Slope (%)	N/A
N/A	Painted X Walk1?	No	N/A	Painted X Walk2?	N/A
	X Walk 1 Direction	To N		X Walk 2 Direction	N/A
N/A	X Walk 1 Width (in)	N/A	N/A	X Walk 2 Width (in)	N/A
	X Walk 1 Slope (%)	1.4		X Walk 2 Slope (%)	N/A
	X Walk 1 X Slope (%)	4.3		X Walk 2 X Slope (%)	N/A

N/A	Ramp inside XWalk1?	N/A	N/A	Ramp inside XWalk2?	N/A
	Road Slope (%)	N/A	N/A	Clear Space?	N/A
	Road X Slope (%)	N/A	N/A	Clear Space to XWalk (in)	N/A
N/A	Any Obstructions?	N/A	N/A	Storm Grate/Utility Hazard?	N/A
	Obstruction Type			Storm Grate/Utility Type	
		N/A			N/A
			Yes	Surface Condition? (G/P)	Good

Possible Solutions:

Remove & Replace Entire Ramp.

PROW/ADA:

Not Found, R304.5.1, R304.5.3
