# Access Compliance Report

## Public Rights-of-Way

### (Curb Ramps)

| Intersection ID: 10036601 | Main Street: RUSHMORE_DR | Cross Street: N/A | Location: S |

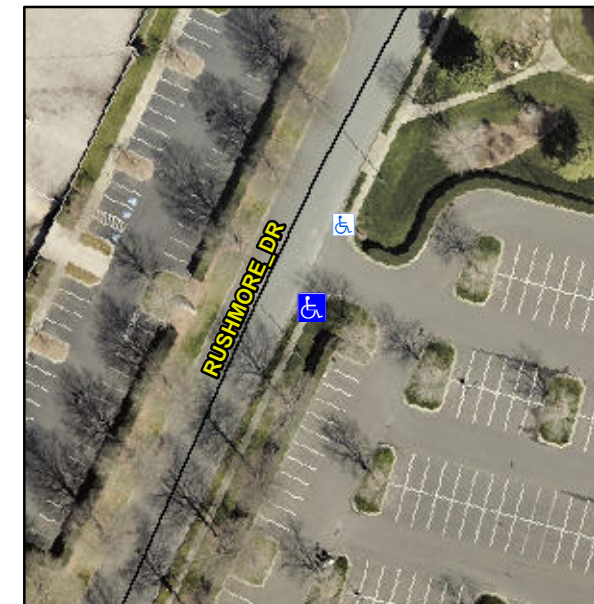
**R304.2.2, R304.5.3**

| Compliance | Description | Data | Compliance | Description | Data |
|---|---|---|---|---|---|
| N/A | Ramp Length (in) | 45.0 | No | Ramp Slope (%) | 11.6 |
| Yes | Ramp Width (in) | 60.0 | No | Ramp XSlope (%) | 8.1 |

**Remove & Replace Curb Ramp With Two New Directional Ramps or Equivalent.**
