Access Compliance Report

Public Rights-of-Way

(Curb Ramps)

Intersection ID: 53413	Main Street: GOLF_LINKS_DR	Cross Street: WAVERLY_WALK_AV	Location: NE
ADA ID: 76E1A41DE577	Ramp Type: Perp	Initial Pass/Fail: Fail	Overall Compliance: No
		Severity Score: 12.5

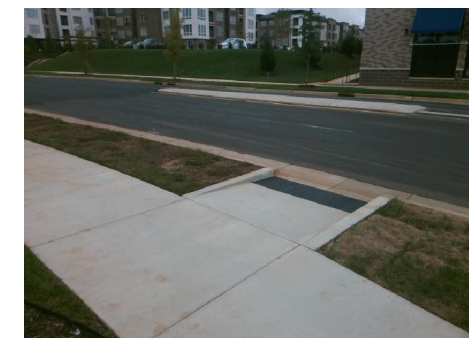
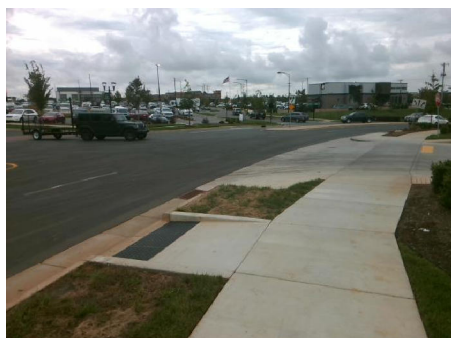
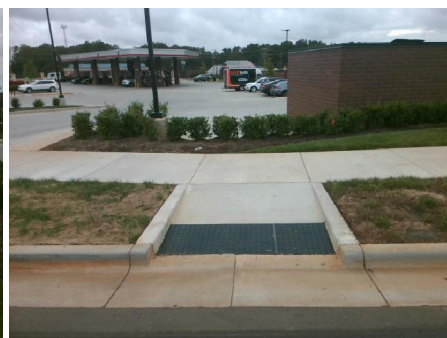
Not Found, R304.2.2

Compliance	Description	Data	Compliance	Description	Data
N/A	Ramp Length (in)	72.0	No	Ramp Slope (%)	9.3
Yes	Ramp Width (in)	71.0	Yes	Ramp XSlope (%)	0.5
N/A	Flare Type LT	N/A	N/A	Flare Type RT	N/A
N/A	Flare Slope LT (%)	N/A	N/A	Flare Slope RT (%)	N/A
N/A	Flare Traversable LT?	N/A	N/A	Flare Traversable RT?	N/A
N/A	Landing Length (in)	N/A	N/A	DWS Provided?	N/A
N/A	Landing Width (in)	N/A	N/A	DWS Contrast?	N/A
N/A	Landing Slope (%)	N/A	N/A	DWS Length (in)	N/A
N/A	Landing X Slope (%)	N/A	N/A	DWS Full Width?	N/A
N/A	Landing Curb? (Y/N)	N/A	N/A	DWS Offset (in)	N/A
N/A	Shared Landing?	N/A			
N/A	Gutter Ponding?	N/A	N/A	Gutter Slope (%)	N/A
N/A	Gutter Lip Ht (in)	N/A	N/A	Gutter X Slope (%)	N/A
N/A	Painted X Walk1?	No	N/A	Painted X Walk2?	N/A
	X Walk 1 Direction	To SE		X Walk 2 Direction	N/A
N/A	X Walk 1 Width (in)	N/A	N/A	X Walk 2 Width (in)	N/A
	X Walk 1 Slope (%)	2.4		X Walk 2 Slope (%)	N/A
	X Walk 1 X Slope (%)	1.2		X Walk 2 X Slope (%)	N/A

Possible Solutions:

Remove & Replace Entire Ramp.
