Access Compliance Report

Public Rights-of-Way

(Curb Ramps)

Intersection ID: 10031842	Main Street: MINTWORTH_AV	Cross Street: N/A	Location: NE
ADA ID: 76E277A8C1EA	Ramp Type: Perp	Initial Pass/Fail: Fail	Overall Compliance: No
			Severity Score: 10

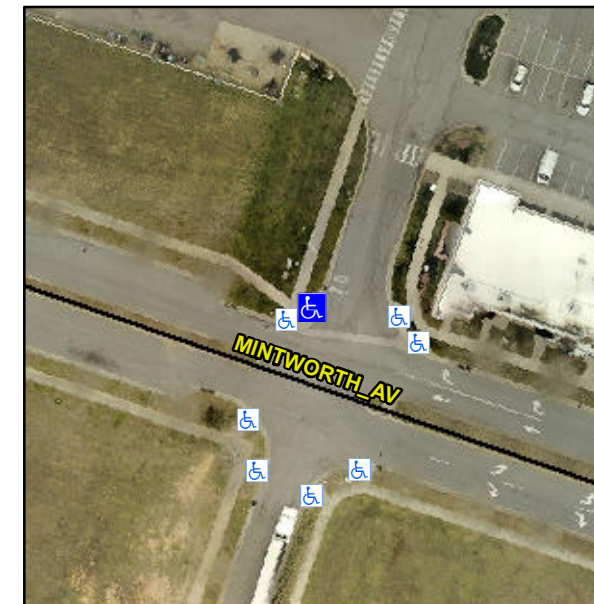
R304.5.1, R304.5.3

Compliance	Description	Data	Compliance	Description	Data
N/A	Ramp Length (in)	94.0	Yes	Ramp Slope (%)	6.9
No	Ramp Width (in)	38.0	No	Ramp XSlope (%)	2.1
N/A	Flare Type LT	N/A	N/A	Flare Type RT	N/A
N/A	Flare Slope LT (%)	N/A	N/A	Flare Slope RT (%)	N/A
N/A	Flare Traversable LT?	N/A	N/A	Flare Traversable RT?	N/A
N/A	Landing Length (in)	N/A	N/A	DWS Provided?	N/A
N/A	Landing Width (in)	N/A	N/A	DWS Contrast?	N/A
N/A	Landing Slope (%)	N/A	N/A	DWS Length (in)	N/A
N/A	Landing X Slope (%)	N/A	N/A	DWS Full Width?	N/A
N/A	Landing Curb? (Y/N)	N/A	N/A	DWS Offset (in)	N/A
N/A	Shared Landing?	N/A			
N/A	Gutter Ponding?	N/A	N/A	Gutter Slope (%)	N/A
N/A	Gutter Lip Ht (in)	N/A	N/A	Gutter X Slope (%)	N/A
N/A	Painted X Walk1?	No	N/A	Painted X Walk2?	N/A
	X Walk 1 Direction	To SE		X Walk 2 Direction	N/A
N/A	X Walk 1 Width (in)	N/A	N/A	X Walk 2 Width (in)	N/A
	X Walk 1 Slope (%)	2.3		X Walk 2 Slope (%)	N/A
	X Walk 1 X Slope (%)	3.7		X Walk 2 X Slope (%)	N/A

N/A	Ramp inside XWalk1?	N/A	N/A	Ramp inside XWalk2?	N/A
	Road Slope (%)	N/A	N/A	Clear Space?	N/A
	Road X Slope (%)	N/A	N/A	Clear Space to XWalk (in)	N/A
N/A	Any Obstructions?	N/A	N/A	Storm Grate/Utility Hazard?	N/A
	Obstruction Type			Storm Grate/Utility Type	
		N/A			N/A
			Yes	Surface Condition? (G/P)	Good

Remove & Replace Entire Ramp.
