Access Compliance Report

Public Rights-of-Way (Curb Ramps)

Intersection ID: 27921	Main Street: BLAKENEY_HEATH_RD	Cross Street: CHARNWOOD_CT	Location: SW
ADA ID: 76F38B6DFDC5	Ramp Type: PerpDiag	Initial Pass/Fail: Fail	Overall Compliance: No
Severity Score: 37.5			
Codes/Mitigation Info/Possible Solution		Field Measurements/Component Compliance

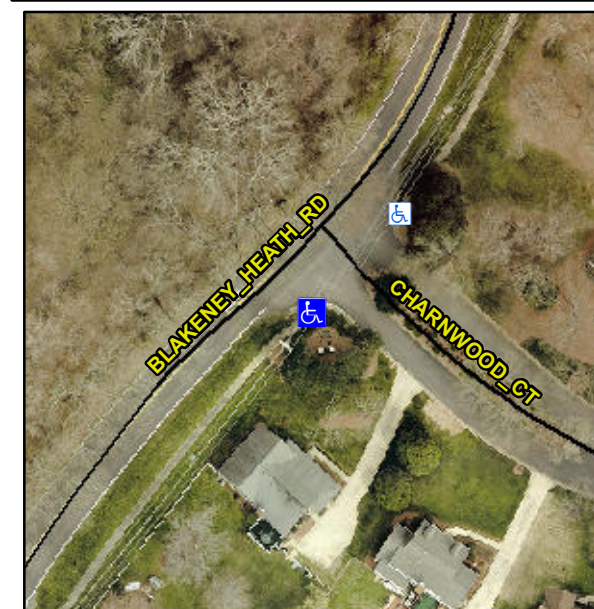
Compliance	Description	Data	Compliance	Description	Data
N/A	Ramp Length (in)	48.0	No	Ramp Slope (%)	14.3
Yes	Ramp Width (in)	48.0	No	Ramp XSlope (%)	6.1
N/A	Flare Type LT	N/A	N/A	Flare Type RT	N/A
N/A	Flare Slope LT (%)	N/A	N/A	Flare Slope RT (%)	N/A
N/A	Flare Traversable LT?	N/A	N/A	Flare Traversable RT?	N/A
N/A	Landing Length (in)	N/A	N/A	DWS Provided?	N/A
N/A	Landing Width (in)	N/A	N/A	DWS Contrast?	N/A
N/A	Landing Slope (%)	N/A	N/A	DWS Length (in)	N/A
N/A	Landing X Slope (%)	N/A	N/A	DWS Full Width?	N/A
N/A	Landing Curb? (Y/N)	N/A	N/A	DWS Offset (in)	N/A
N/A	Shared Landing?	N/A			
N/A	Gutter Ponding?	N/A	N/A	Gutter Slope (%)	N/A
N/A	Gutter Lip Ht (in)	N/A	N/A	Gutter X Slope (%)	N/A
N/A	Painted X Walk1?	No	N/A	Painted X Walk2?	No
	X Walk 1 Direction	To NE		X Walk 2 Direction	To NW
N/A	X Walk 1 Width (in)	N/A	N/A	X Walk 2 Width (in)	N/A
	X Walk 1 Slope (%)	0.3		X Walk 2 Slope (%)	2.5
	X Walk 1 X Slope (%)	2.2		X Walk 2 X Slope (%)	1.4

N/A	Ramp inside XWalk1?	N/A	N/A	Ramp inside XWalk2?	N/A
	Road Slope (%)	2.6	N/A	Clear Space?	N/A
	Road X Slope (%)	1.4	N/A	Clear Space to XWalk (in)	N/A
N/A	Any Obstructions?	N/A	N/A	Storm Grate/Utility Hazard?	N/A
	Obstruction Type			Storm Grate/Utility Type	
		N/A			N/A
			Yes	Surface Condition? (G/P)	Good

Remove & Replace Curb Ramp With Two New Directional Ramps or Equivalent.

R304.2.2, R304.5.3
