Access Compliance Report

Public Rights-of-Way

(Curb Ramps)

Intersection ID: 7629	Main Street: AMBLE_DR	Cross Street: PEBBLE_ST	Location: SW
ADA ID: 770936645474	Ramp Type: Perp	Initial Pass/Fail: Fail	Overall Compliance: No
Severity Score: 26.25			
Codes/Mitigation Info/Possible Solution		Field Measurements/Component Compliance

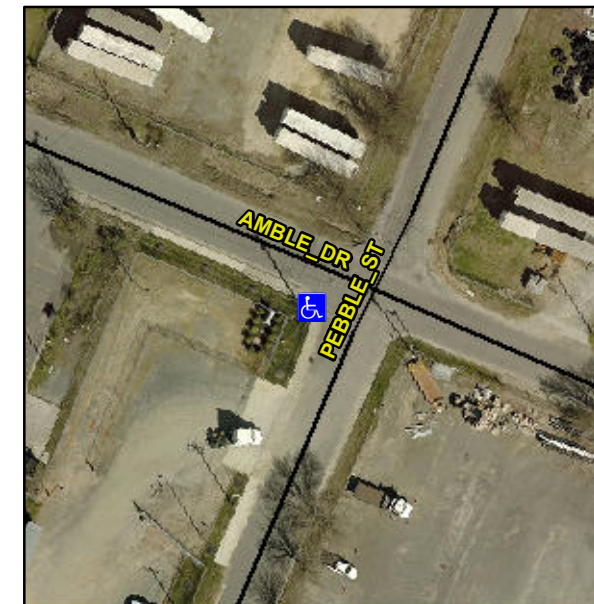
Not Found, R304.2.2

Compliance	Description	Data	Compliance	Description	Data
N/A	Ramp Length (in)	49.0	No	Ramp Slope (%)	13.0
Yes	Ramp Width (in)	60.0	Yes	Ramp XSlope (%)	3.1
N/A	Flare Type LT	N/A	N/A	Flare Type RT	N/A
N/A	Flare Slope LT (%)	N/A	N/A	Flare Slope RT (%)	N/A
N/A	Flare Traversable LT?	N/A	N/A	Flare Traversable RT?	N/A
N/A	Landing Length (in)	N/A	N/A	DWS Provided?	N/A
N/A	Landing Width (in)	N/A	N/A	DWS Contrast?	N/A
N/A	Landing Slope (%)	N/A	N/A	DWS Length (in)	N/A
N/A	Landing X Slope (%)	N/A	N/A	DWS Full Width?	N/A
N/A	Landing Curb? (Y/N)	N/A	N/A	DWS Offset (in)	N/A
N/A	Shared Landing?	N/A			
N/A	Gutter Ponding?	N/A	N/A	Gutter Slope (%)	N/A
N/A	Gutter Lip Ht (in)	1.0	N/A	Gutter X Slope (%)	N/A
N/A	Painted X Walk1?	No	N/A	Painted X Walk2?	N/A
	X Walk 1 Direction	To NE		X Walk 2 Direction	N/A
N/A	X Walk 1 Width (in)	N/A	N/A	X Walk 2 Width (in)	N/A
	X Walk 1 Slope (%)	2.6		X Walk 2 Slope (%)	N/A
	X Walk 1 X Slope (%)	8.4		X Walk 2 X Slope (%)	N/A

N/A	Ramp inside XWalk1?	N/A	N/A	Ramp inside XWalk2?	N/A
	Road Slope (%)	8.4	N/A	Clear Space?	N/A
	Road X Slope (%)	2.6	N/A	Clear Space to XWalk (in)	N/A
N/A	Any Obstructions?	N/A	N/A	Storm Grate/Utility Hazard?	N/A
	Obstruction Type			Storm Grate/Utility Type	
		N/A			N/A
			Yes	Surface Condition? (G/P)	Good

Remove & Replace Entire Ramp.
