Access Compliance Report

Public Rights-of-Way

(Curb Ramps)

Intersection ID: 14373	Main Street: EAST_BV	Cross Street: LYNDHURST_AV	Location: NE
ADA ID: 77099EA15B85	Ramp Type: BlendTrans1	Initial Pass/Fail: Fail	Overall Compliance: No
Severity Score: 1.25			
Codes/Mitigation Info/Possible Solution		Field Measurements/Component Compliance

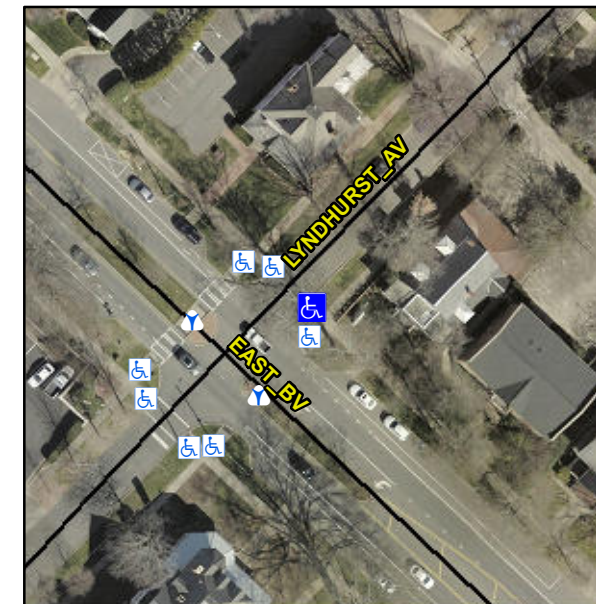
Not Found, R304.5.3

Compliance	Description	Data	Compliance	Description	Data
N/A	Ramp Length (in)	68.0	Yes	BlendTrans Slope (%)	4.8
Yes	Ramp Width (in)	70.5	No	BlendTrans XSlope (%)	2.4
N/A	Flare Type LT	N/A	N/A	Flare Type RT	N/A
N/A	Flare Slope LT (%)	N/A	N/A	Flare Slope RT (%)	N/A
N/A	Flare Traversable LT?	N/A	N/A	Flare Traversable RT?	N/A
N/A	Landing Length (in)	N/A	N/A	DWS Provided?	N/A
N/A	Landing Width (in)	N/A	N/A	DWS Contrast?	N/A
N/A	Landing Slope (%)	N/A	N/A	DWS Length (in)	N/A
N/A	Landing X Slope (%)	N/A	N/A	DWS Full Width?	N/A
N/A	Landing Curb? (Y/N)	N/A	N/A	DWS Offset (in)	N/A
N/A	Shared Landing?	N/A			
N/A	Gutter Ponding?	N/A	N/A	Gutter Slope (%)	N/A
N/A	Gutter Lip Ht (in)	N/A	N/A	Gutter X Slope (%)	N/A
N/A	Painted X Walk1?	No	N/A	Painted X Walk2?	N/A
	X Walk 1 Direction	To NW		X Walk 2 Direction	N/A
	X Walk 1 Width (in)	N/A		X Walk 2 Width (in)	N/A
	X Walk 1 Slope (%)	3.5		X Walk 2 Slope (%)	N/A
	X Walk 1 X Slope (%)	2.0		X Walk 2 X Slope (%)	N/A

N/A	Ramp inside XWalk1?	N/A	N/A	Ramp inside XWalk2?	N/A
	Road Slope (%)	2.0		Clear Space?	N/A
	Road X Slope (%)	3.5	N/A	Clear Space to XWalk (in)	N/A
N/A	Any Obstructions?	N/A	N/A	Storm Grate/Utility Hazard?	N/A
	Obstruction Type			Storm Grate/Utility Type	
		N/A			N/A
			Yes	Surface Condition? (G/P)	Good
			No	Curb Slope (%)	7.9

Remove & Replace Curb Ramp With Two New Directional Ramps or Equivalent.
