Access Compliance Report

Public Rights-of-Way

(Curb Ramps)

Intersection ID: 48634	Main Street: GRANDE_HEIGHTS_DR	Cross Street: DOMINION_CREST_DR	Location: NW
ADA ID: 770D3EB14CDD	Ramp Type: Perp	Initial Pass/Fail: Fail	Overall Compliance: No
Severity Score: 10			
Codes/Mitigation Info/Possible Solution		Field Measurements/Component Compliance

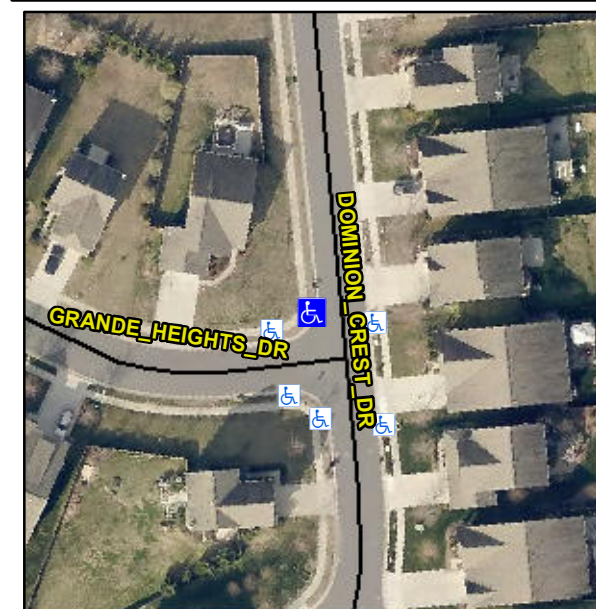
R304.5.1, R304.5.3

Compliance	Description	Data	Compliance	Description	Data
N/A	Ramp Length (in)	47.0	Yes	Ramp Slope (%)	5.6
No	Ramp Width (in)	47.0	No	Ramp XSlope (%)	4.1
N/A	Flare Type LT	N/A	N/A	Flare Type RT	N/A
N/A	Flare Slope LT (%)	N/A	N/A	Flare Slope RT (%)	N/A
N/A	Flare Traversable LT?	N/A	N/A	Flare Traversable RT?	N/A
N/A	Landing Length (in)	N/A	N/A	DWS Provided?	N/A
N/A	Landing Width (in)	N/A	N/A	DWS Contrast?	N/A
N/A	Landing Slope (%)	N/A	N/A	DWS Length (in)	N/A
N/A	Landing X Slope (%)	N/A	N/A	DWS Full Width?	N/A
N/A	Landing Curb? (Y/N)	N/A	N/A	DWS Offset (in)	N/A
N/A	Shared Landing?	N/A			
N/A	Gutter Ponding?	N/A	N/A	Gutter Slope (%)	N/A
N/A	Gutter Lip Ht (in)	N/A	N/A	Gutter X Slope (%)	N/A
N/A	Painted X Walk1?	No	N/A	Painted X Walk2?	N/A
	X Walk 1 Direction	To E		X Walk 2 Direction	N/A
N/A	X Walk 1 Width (in)	N/A	N/A	X Walk 2 Width (in)	N/A
	X Walk 1 Slope (%)	4.1		X Walk 2 Slope (%)	N/A
	X Walk 1 X Slope (%)	1.9		X Walk 2 X Slope (%)	N/A

N/A	Ramp inside XWalk1?	N/A	N/A	Ramp inside XWalk2?	N/A
	Road Slope (%)	N/A	N/A	Clear Space?	N/A
	Road X Slope (%)	N/A	N/A	Clear Space to XWalk (in)	N/A
N/A	Any Obstructions?	N/A	N/A	Storm Grate/Utility Hazard?	N/A
	Obstruction Type			Storm Grate/Utility Type	
		N/A			N/A
		Yes		Surface Condition? (G/P)	Good

Possible Solutions:

Remove & Replace Entire Ramp.
