# Access Compliance Report

## Public Rights-of-Way

### (Curb Ramps)

Intersection ID: 15336	Main Street: E_INDEPENDENCE_BV	Cross Street: WOODLAND_DR	Location: NE
ADA ID: 771609A3E991	Ramp Type: Perp	Initial Pass/Fail: Fail	Overall Compliance: No
Severity Score: 21.25			
Codes/Mitigation Info/Possible Solution		Field Measurements/Component Compliance

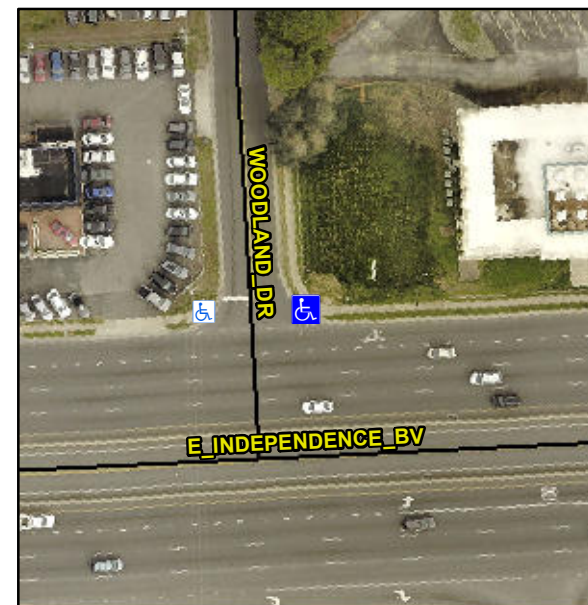
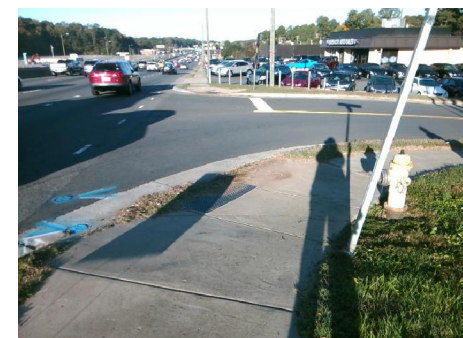
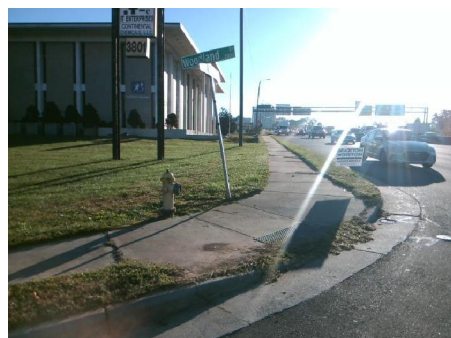
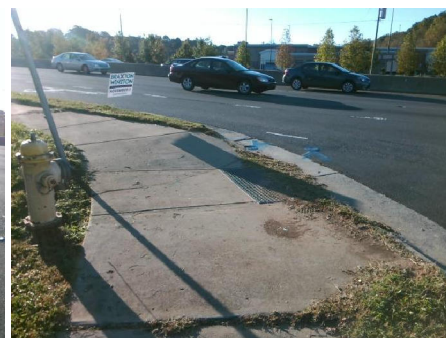
**Not Found, R304.5.1, R304.5.3**

Compliance	Description	Data	Compliance	Description	Data
N/A	Ramp Length (in)	89.0	Yes	Ramp Slope (%)	6.2
No	Ramp Width (in)	43.5	No	Ramp XSlope (%)	5.2
N/A	Flare Type LT	N/A	N/A	Flare Type RT	N/A
N/A	Flare Slope LT (%)	N/A	N/A	Flare Slope RT (%)	N/A
N/A	Flare Traversable LT?	N/A	N/A	Flare Traversable RT?	N/A
N/A	Landing Length (in)	N/A	N/A	DWS Provided?	N/A
N/A	Landing Width (in)	N/A	N/A	DWS Contrast?	N/A
N/A	Landing Slope (%)	N/A	N/A	DWS Length (in)	N/A
N/A	Landing X Slope (%)	N/A	N/A	DWS Full Width?	N/A
N/A	Landing Curb? (Y/N)	N/A	N/A	DWS Offset (in)	N/A
N/A	Shared Landing?	N/A			
N/A	Gutter Ponding?	N/A	N/A	Gutter Slope (%)	N/A
N/A	Gutter Lip Ht (in)	N/A	N/A	Gutter X Slope (%)	N/A
N/A	Painted X Walk1?	No	N/A	Painted X Walk2?	N/A
	X Walk 1 Direction	To W		X Walk 2 Direction	N/A
N/A	X Walk 1 Width (in)	N/A	N/A	X Walk 2 Width (in)	N/A
	X Walk 1 Slope (%)	4.6		X Walk 2 Slope (%)	N/A
	X Walk 1 X Slope (%)	4.1		X Walk 2 X Slope (%)	N/A

N/A	Ramp inside XWalk1?	N/A	N/A	Ramp inside XWalk2?	N/A
	Road Slope (%)	N/A	N/A	Clear Space?	N/A
	Road X Slope (%)	N/A	N/A	Clear Space to XWalk (in)	N/A
N/A	Any Obstructions?	N/A	N/A	Storm Grate/Utility Hazard?	N/A
	Obstruction Type			Storm Grate/Utility Type	
		N/A			N/A
			Yes	Surface Condition? (G/P)	Good

**Remove & Replace Entire Ramp.**
