Access Compliance Report

Public Rights-of-Way

(Curb Ramps)

Intersection ID: 10024493	Main Street: CROWNPOINT_EXECUTIVE_DR	Cross Street: N/A	Location: NW
ADA ID: 7717BF5332AE	Ramp Type: Perp	Initial Pass/Fail: Fail	Overall Compliance: No
Severity Score: 26.25			
Codes/Mitigation Info/Possible Solution		Field Measurements/Component Compliance

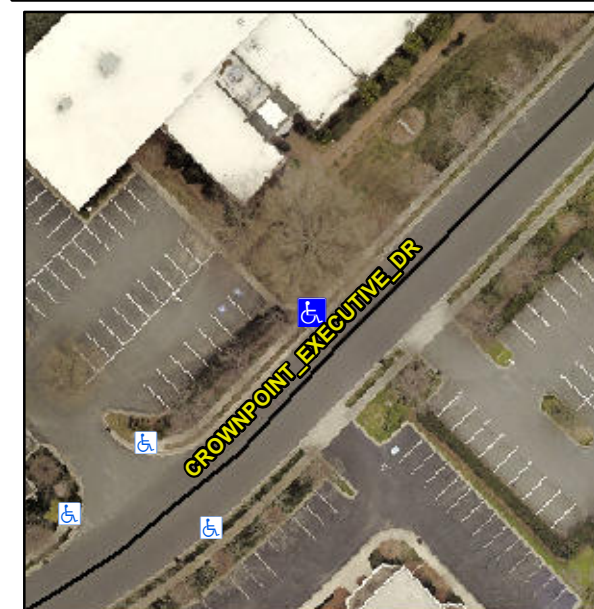
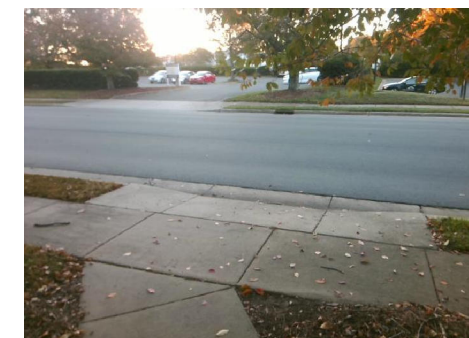
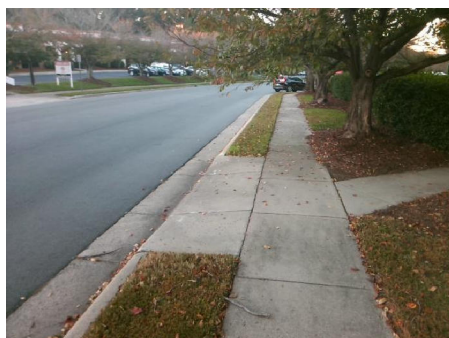
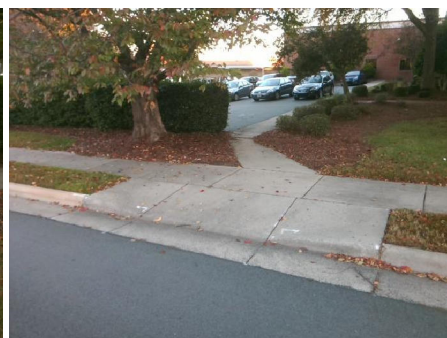
Not Found, R304.2.2, R304.5.3

Compliance	Description	Data	Compliance	Description	Data
N/A	Ramp Length (in)	46.0	No	Ramp Slope (%)	13.7
Yes	Ramp Width (in)	76.0	No	Ramp XSlope (%)	4.8
N/A	Flare Type LT	N/A	N/A	Flare Type RT	N/A
N/A	Flare Slope LT (%)	N/A	N/A	Flare Slope RT (%)	N/A
N/A	Flare Traversable LT?	N/A	N/A	Flare Traversable RT?	N/A
N/A	Landing Length (in)	N/A	N/A	DWS Provided?	N/A
N/A	Landing Width (in)	N/A	N/A	DWS Contrast?	N/A
N/A	Landing Slope (%)	N/A	N/A	DWS Length (in)	N/A
N/A	Landing X Slope (%)	N/A	N/A	DWS Full Width?	N/A
N/A	Landing Curb? (Y/N)	N/A	N/A	DWS Offset (in)	N/A
N/A	Shared Landing?	N/A			
N/A	Gutter Ponding?	N/A	N/A	Gutter Slope (%)	N/A
N/A	Gutter Lip Ht (in)	N/A	N/A	Gutter X Slope (%)	N/A
N/A	Painted X Walk1?	No	N/A	Painted X Walk2?	N/A
	X Walk 1 Direction	To SE		X Walk 2 Direction	N/A
N/A	X Walk 1 Width (in)	N/A	N/A	X Walk 2 Width (in)	N/A
	X Walk 1 Slope (%)	3.1		X Walk 2 Slope (%)	N/A
	X Walk 1 X Slope (%)	3.5		X Walk 2 X Slope (%)	N/A

N/A	Ramp inside XWalk1?	N/A	N/A	Ramp inside XWalk2?	N/A
	Road Slope (%)	N/A	N/A	Clear Space?	N/A
	Road X Slope (%)	N/A	N/A	Clear Space to XWalk (in)	N/A
N/A	Any Obstructions?	N/A	N/A	Storm Grate/Utility Hazard?	N/A
	Obstruction Type			Storm Grate/Utility Type	
		N/A			N/A
			Yes	Surface Condition? (G/P)	Good

Possible Solutions:

Remove & Replace Entire Ramp.
