# Access Compliance Report

## Public Rights-of-Way

| Intersection ID: 8303 | Main Street: IRMA_ST | Cross Street: CATHERINE_SIMMONS_AV | Location: NE |
| ADA ID: 771C974FB86C | Ramp Type: PerpDiag | Initial Pass/Fail: Fail | Overall Compliance: No |

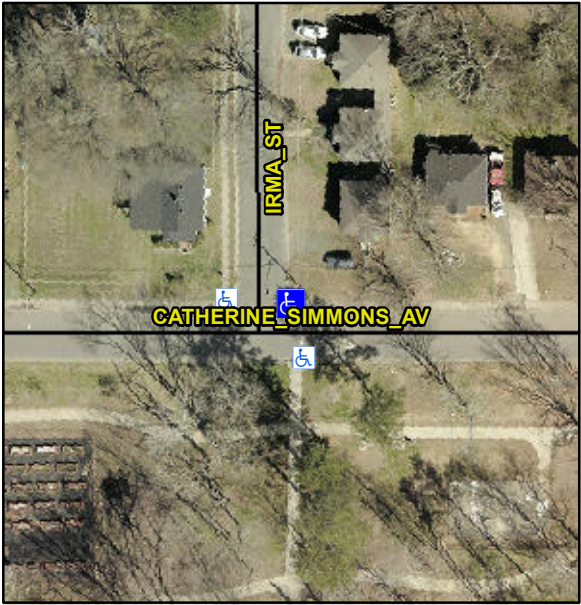
| | | Severity Score: 33.75 | |

| Codes/Mitigation Info/Possible Solution | | Field Measurements/Component Compliance | | | | | |
|--|---|---|---|---|---|---|---|
| | <p>Surveyor Notes:</p> <p><b>N/A</b></p> <p>PROW/ADA:</p> <p><b>R304.5.1, R304.5.3</b></p> | N/A | Ramp Length (in) | 55.5 | Yes | Ramp Slope (%) | 6.2 |
| | | No | Ramp Width (in) | 44.0 | No | Ramp XSlope (%) | 11.6 |

| Codes/Mitigation Info/Possible Solution | | Field Measurements/Component Compliance | | | | | |
|--|---|---|---|---|---|---|---|
| | <p>Possible Solutions:</p> <p><b>Remove &amp; Replace Curb Ramp With Two New Directional Ramps or Equivalent.</b></p> | <b>Compliance</b> | <b>Description</b> | <b>Data</b> | <b>Compliance</b> | <b>Description</b> | <b>Data</b> |
