# Access Compliance Report

## Public Rights-of-Way

### (Curb Ramps)

Intersection ID: 43750	Main Street: POTTERS_GLEN_RD	Cross Street: EARTHENWARE_DR	Location:	N
ADA ID: 771D5787EDCE	Ramp Type: PerpDiag	Initial Pass/Fail: Fail	Overall Compliance: No	Severity Score: 25
Codes/Mitigation Info/Possible Solution		Field Measurements/Component Compliance

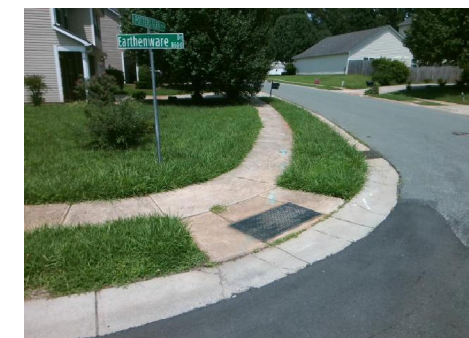
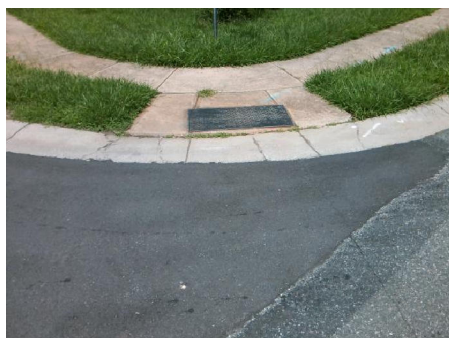
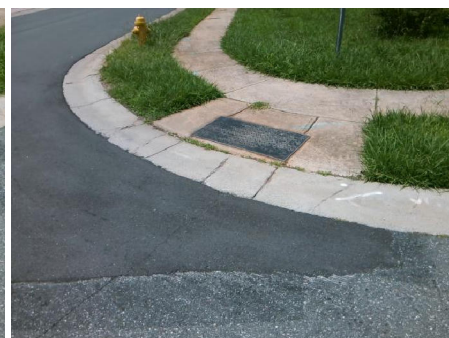
Compliance	Description	Data	Compliance	Description	Data
N/A	Ramp Length (in)	47.5	Yes	Ramp Slope (%)	6.6
No	Ramp Width (in)	36.0	No	Ramp XSlope (%)	2.4
N/A	Flare Type LT	N/A	N/A	Flare Type RT	N/A
N/A	Flare Slope LT (%)	N/A	N/A	Flare Slope RT (%)	N/A
N/A	Flare Traversable LT?	N/A	N/A	Flare Traversable RT?	N/A
N/A	Landing Length (in)	N/A	N/A	DWS Provided?	N/A
N/A	Landing Width (in)	N/A	N/A	DWS Contrast?	N/A
N/A	Landing Slope (%)	N/A	N/A	DWS Length (in)	N/A
N/A	Landing X Slope (%)	N/A	N/A	DWS Full Width?	N/A
N/A	Landing Curb? (Y/N)	N/A	N/A	DWS Offset (in)	N/A
N/A	Shared Landing?	N/A			
N/A	Gutter Ponding?	N/A	N/A	Gutter Slope (%)	N/A
N/A	Gutter Lip Ht (in)	N/A	N/A	Gutter X Slope (%)	N/A
N/A	Painted X Walk1?	No	N/A	Painted X Walk2?	No
	X Walk 1 Direction	To SW		X Walk 2 Direction	To SE
N/A	X Walk 1 Width (in)	N/A	N/A	X Walk 2 Width (in)	N/A
	X Walk 1 Slope (%)	5.8		X Walk 2 Slope (%)	6.2
	X Walk 1 X Slope (%)	0.7		X Walk 2 X Slope (%)	0.6

N/A	Ramp inside XWalk1?	N/A	N/A	Ramp inside XWalk2?	N/A
	Road Slope (%)	1.4	N/A	Clear Space?	N/A
	Road X Slope (%)	6.6	N/A	Clear Space to XWalk (in)	N/A
N/A	Any Obstructions?	N/A	N/A	Storm Grate/Utility Hazard?	N/A
	Obstruction Type			Storm Grate/Utility Type	
		N/A			N/A
		No		Surface Condition? (G/P)	Poor

**Remove & Replace Curb Ramp With Two New Directional Ramps or Equivalent.**

**R304.5.1, R304.5.3, R302.7**
