# Access Compliance Report

## Public Rights-of-Way

### (Curb Ramps)

| Intersection ID: 54318 | Main Street: CANTERBURY CASTLE DR | Cross Street: BELMONT MANSION DR | Location: SW |

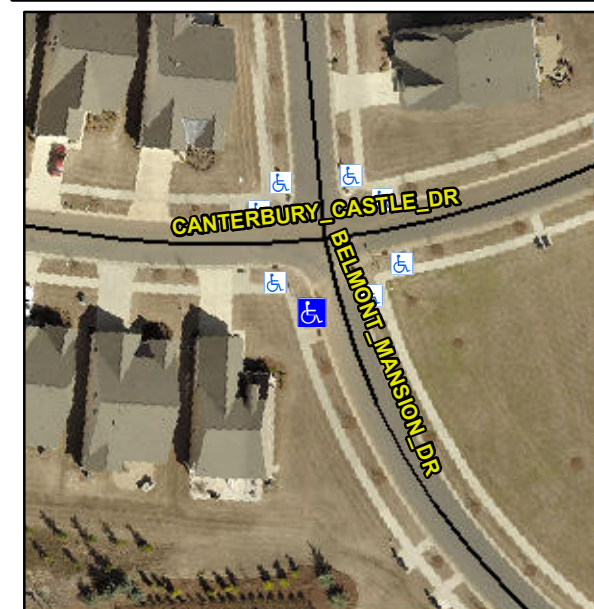
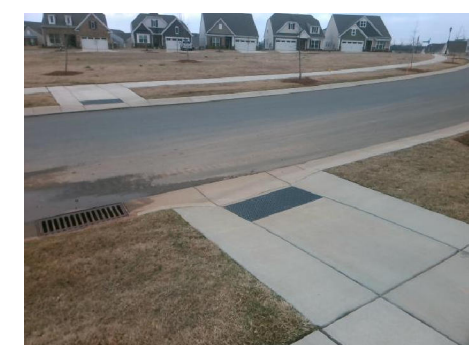
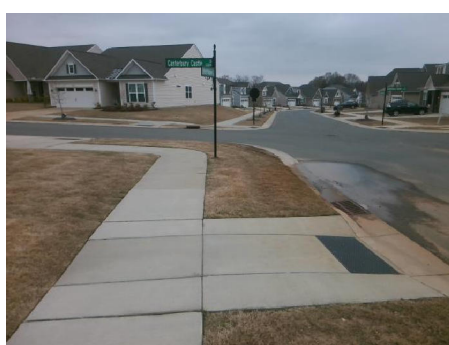
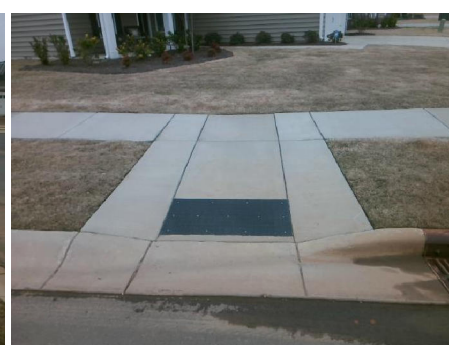
| ADA ID: 772564E85E6B | Ramp Type: Perp | Initial Pass/Fail: Fail | Overall Compliance: No |
| Severity Score: 22.5 | | | |

**Not Found, R304.5.1, R304.2.2, R304.5.3**

| Compliance | Description | Data | Compliance | Description | Data |
|---|---|---|---|---|---|
| N/A | Ramp Length (in) | 93.0 | No | Ramp Slope (%) | 8.6 |
| No | Ramp Width (in) | 47.5 | No | Ramp XSlope (%) | 2.3 |

**Remove & Replace Entire Ramp.**
