Access Compliance Report

Public Rights-of-Way

(Curb Ramps)

Intersection ID: 13156	Main Street: S_TRYON_ST	Cross Street: W_CARSON_BV	Location: SE
ADA ID: 7726DFCB4588	Ramp Type: Perp	Initial Pass/Fail: Fail	Overall Compliance: No
Severity Score: 12.5			
Codes/Mitigation Info/Possible Solution		Field Measurements/Component Compliance

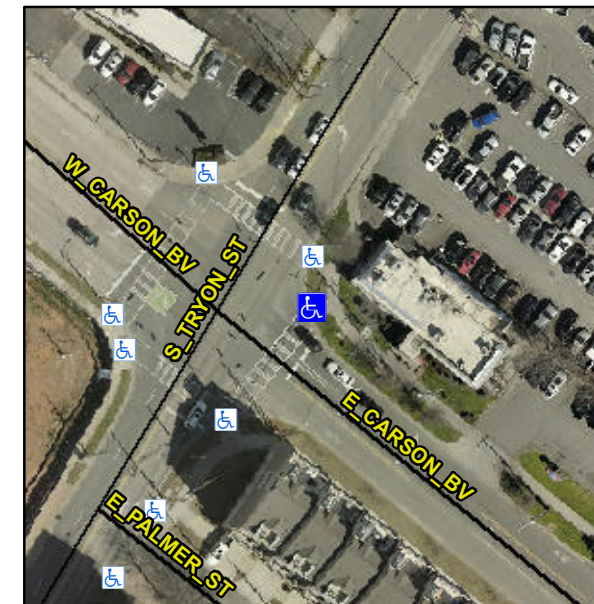
Not Found, R304.2.2

Compliance	Description	Data	Compliance	Description	Data
N/A	Ramp Length (in)	124.0	No	Ramp Slope (%)	9.0
Yes	Ramp Width (in)	74.0	Yes	Ramp XSlope (%)	1.4
N/A	Flare Type LT	N/A	N/A	Flare Type RT	N/A
N/A	Flare Slope LT (%)	N/A	N/A	Flare Slope RT (%)	N/A
N/A	Flare Traversable LT?	N/A	N/A	Flare Traversable RT?	N/A
N/A	Landing Length (in)	N/A	N/A	DWS Provided?	N/A
N/A	Landing Width (in)	N/A	N/A	DWS Contrast?	N/A
N/A	Landing Slope (%)	N/A	N/A	DWS Length (in)	N/A
N/A	Landing X Slope (%)	N/A	N/A	DWS Full Width?	N/A
N/A	Landing Curb? (Y/N)	N/A	N/A	DWS Offset (in)	N/A
N/A	Shared Landing?	N/A			
N/A	Gutter Ponding?	N/A	N/A	Gutter Slope (%)	N/A
N/A	Gutter Lip Ht (in)	N/A	N/A	Gutter X Slope (%)	N/A
N/A	Painted X Walk1?	Yes	N/A	Painted X Walk2?	N/A
	X Walk 1 Direction	To SW		X Walk 2 Direction	N/A
N/A	X Walk 1 Width (in)	112.0	N/A	X Walk 2 Width (in)	N/A
	X Walk 1 Slope (%)	4.2		X Walk 2 Slope (%)	N/A
	X Walk 1 X Slope (%)	2.1		X Walk 2 X Slope (%)	N/A

Remove & Replace Entire Ramp.

Total Cost: \$ 1850.00
