# Access Compliance Report

## Public Rights-of-Way

### (Curb Ramps)

Intersection ID: 13057	Main Street: E_MOREHEAD_ST	Cross Street: S_COLLEGE_ST	Location: NE
ADA ID: 773A63A9378A	Ramp Type: PerpDiag	Initial Pass/Fail: Fail	Overall Compliance: No
Codes/Mitigation Info/Possible Solution		Field Measurements/Component Compliance	
Severity Score: 43.75

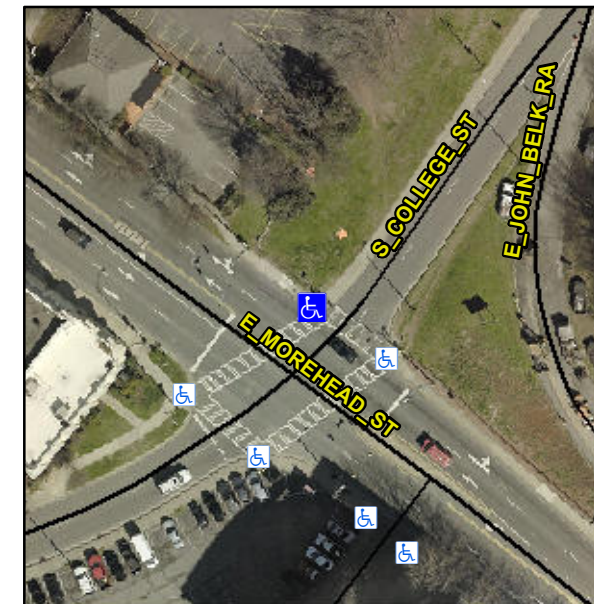
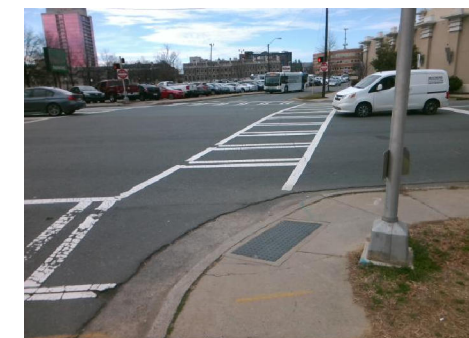
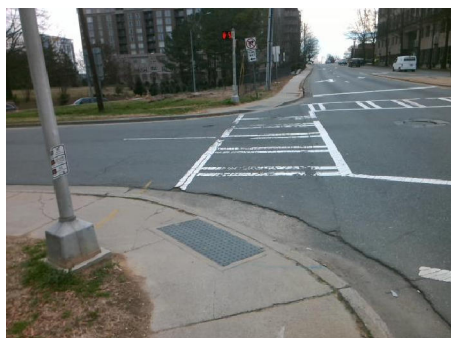
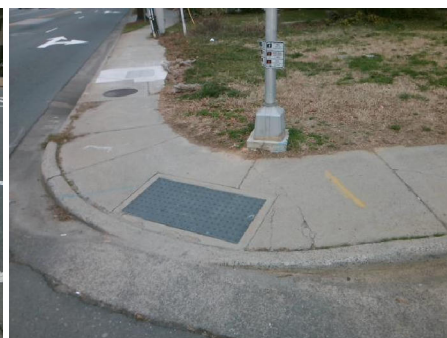
**Not Found, R304.5.1, R304.2.2, R304.5.3**

Compliance	Description	Data	Compliance	Description	Data
N/A	Ramp Length (in)	60.0	No	Ramp Slope (%)	12.6
No	Ramp Width (in)	34.0	No	Ramp XSlope (%)	3.2
N/A	Flare Type LT	N/A	N/A	Flare Type RT	N/A
N/A	Flare Slope LT (%)	N/A	N/A	Flare Slope RT (%)	N/A
N/A	Flare Traversable LT?	N/A	N/A	Flare Traversable RT?	N/A
N/A	Landing Length (in)	N/A	N/A	DWS Provided?	N/A
N/A	Landing Width (in)	N/A	N/A	DWS Contrast?	N/A
N/A	Landing Slope (%)	N/A	N/A	DWS Length (in)	N/A
N/A	Landing X Slope (%)	N/A	N/A	DWS Full Width?	N/A
N/A	Landing Curb? (Y/N)	N/A	N/A	DWS Offset (in)	N/A
N/A	Shared Landing?	N/A			
N/A	Gutter Ponding?	N/A	N/A	Gutter Slope (%)	N/A
N/A	Gutter Lip Ht (in)	N/A	N/A	Gutter X Slope (%)	N/A
N/A	Painted X Walk1?	Yes	N/A	Painted X Walk2?	Yes
	X Walk 1 Direction	To SW		X Walk 2 Direction	To SE
N/A	X Walk 1 Width (in)	101.0	N/A	X Walk 2 Width (in)	103.0
	X Walk 1 Slope (%)	2.9		X Walk 2 Slope (%)	2.4
	X Walk 1 X Slope (%)	2.9		X Walk 2 X Slope (%)	0.1

N/A	Ramp inside XWalk1?	Yes	N/A	Ramp inside XWalk2?	Yes
	Road Slope (%)	1.4	N/A	Clear Space?	N/A
	Road X Slope (%)	1.8	N/A	Clear Space to XWalk (in)	N/A
N/A	Any Obstructions?	N/A	N/A	Storm Grate/Utility Hazard?	N/A
	Obstruction Type			Storm Grate/Utility Type	
		N/A			N/A
		Yes		Surface Condition? (G/P)	Good

**Remove & Replace Curb Ramp With Two New Directional Ramps or Equivalent.**
