Access Compliance Report

Public Rights-of-Way

(Curb Ramps)

Intersection ID: 13627	Main Street: COMMONWEALTH_AV	Cross Street: WESTOVER_ST	Location: S
ADA ID: 77470E796B8E	Ramp Type: Perp	Initial Pass/Fail: Fail	Overall Compliance: No
Codes/Mitigation Info/Possible Solution		Field Measurements/Component Compliance	
Severity Score: 8.75

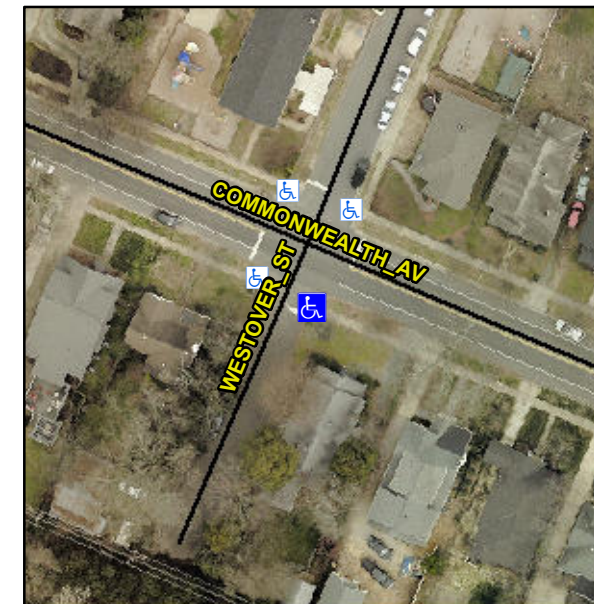
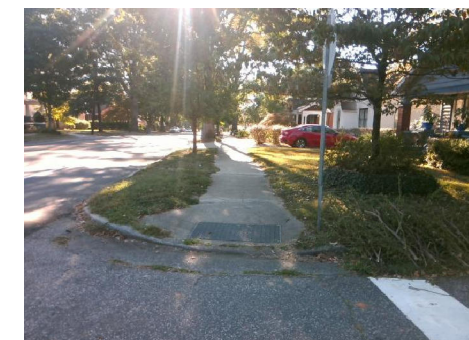
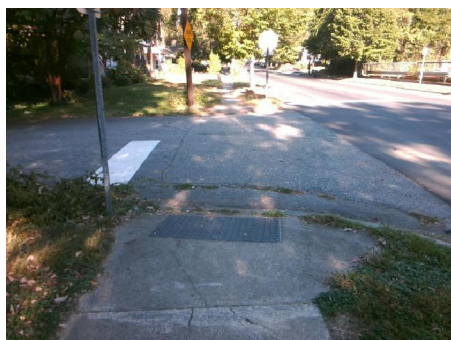
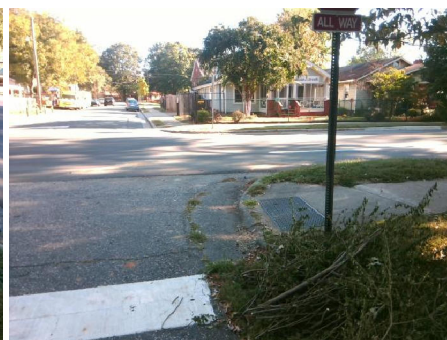
Not Found, R304.5.1

Compliance	Description	Data	Compliance	Description	Data
N/A	Ramp Length (in)	75.5	Yes	Ramp Slope (%)	7.7
No	Ramp Width (in)	46.0	Yes	Ramp XSlope (%)	0.7
N/A	Flare Type LT	N/A	N/A	Flare Type RT	N/A
N/A	Flare Slope LT (%)	N/A	N/A	Flare Slope RT (%)	N/A
N/A	Flare Traversable LT?	N/A	N/A	Flare Traversable RT?	N/A
N/A	Landing Length (in)	N/A	N/A	DWS Provided?	N/A
N/A	Landing Width (in)	N/A	N/A	DWS Contrast?	N/A
N/A	Landing Slope (%)	N/A	N/A	DWS Length (in)	N/A
N/A	Landing X Slope (%)	N/A	N/A	DWS Full Width?	N/A
N/A	Landing Curb? (Y/N)	N/A	N/A	DWS Offset (in)	N/A
N/A	Shared Landing?	N/A			
N/A	Gutter Ponding?	N/A	N/A	Gutter Slope (%)	N/A
N/A	Gutter Lip Ht (in)	N/A	N/A	Gutter X Slope (%)	N/A
N/A	Painted X Walk1?	No	N/A	Painted X Walk2?	N/A
	X Walk 1 Direction	To NW		X Walk 2 Direction	N/A
N/A	X Walk 1 Width (in)	N/A	N/A	X Walk 2 Width (in)	N/A
	X Walk 1 Slope (%)	3.1		X Walk 2 Slope (%)	N/A
	X Walk 1 X Slope (%)	0.9		X Walk 2 X Slope (%)	N/A

N/A	Ramp inside XWalk1?	N/A	N/A	Ramp inside XWalk2?	N/A
	Road Slope (%)	N/A	N/A	Clear Space?	N/A
	Road X Slope (%)	N/A	N/A	Clear Space to XWalk (in)	N/A
N/A	Any Obstructions?	N/A	N/A	Storm Grate/Utility Hazard?	N/A
	Obstruction Type			Storm Grate/Utility Type	
		N/A			N/A
		Yes		Surface Condition? (G/P)	Good

Remove & Replace Entire Ramp.

Total Cost: \$ 1850.00
