# Access Compliance Report

## Public Rights-of-Way

### (Curb Ramps)

Intersection ID: 20422	Main Street: W_ARROWOOD_RD	Cross Street: S_TRYON_ST	Location: SW
ADA ID: 775BEE6BB16B	Ramp Type: Perp	Initial Pass/Fail: Fail	Overall Compliance: No
Severity Score: 21.25			
Codes/Mitigation Info/Possible Solution		Field Measurements/Component Compliance

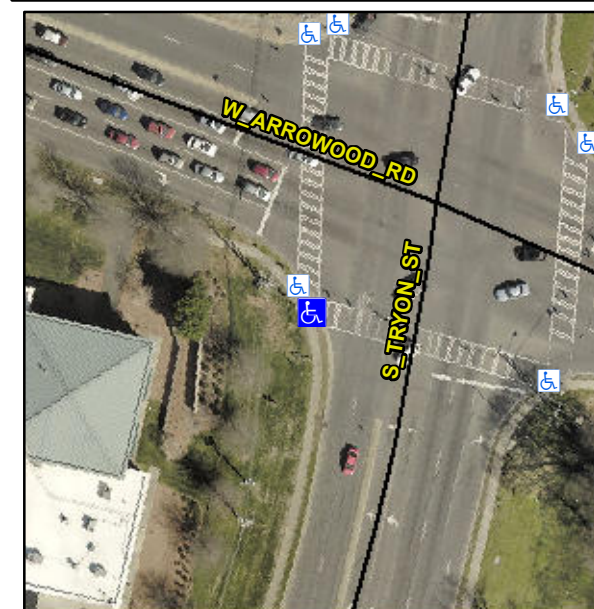
**Not Found, R304.5.1, R304.2.2**

Compliance	Description	Data	Compliance	Description	Data
N/A	Ramp Length (in)	64.0	No	Ramp Slope (%)	9.2
No	Ramp Width (in)	47.0	Yes	Ramp XSlope (%)	1.4
N/A	Flare Type LT	N/A	N/A	Flare Type RT	N/A
N/A	Flare Slope LT (%)	N/A	N/A	Flare Slope RT (%)	N/A
N/A	Flare Traversable LT?	N/A	N/A	Flare Traversable RT?	N/A
N/A	Landing Length (in)	N/A	N/A	DWS Provided?	N/A
N/A	Landing Width (in)	N/A	N/A	DWS Contrast?	N/A
N/A	Landing Slope (%)	N/A	N/A	DWS Length (in)	N/A
N/A	Landing X Slope (%)	N/A	N/A	DWS Full Width?	N/A
N/A	Landing Curb? (Y/N)	N/A	N/A	DWS Offset (in)	N/A
N/A	Shared Landing?	N/A			
N/A	Gutter Ponding?	N/A	N/A	Gutter Slope (%)	N/A
N/A	Gutter Lip Ht (in)	N/A	N/A	Gutter X Slope (%)	N/A
N/A	Painted X Walk1?	Yes	N/A	Painted X Walk2?	N/A
	X Walk 1 Direction	To SE		X Walk 2 Direction	N/A
N/A	X Walk 1 Width (in)	136.0	N/A	X Walk 2 Width (in)	N/A
	X Walk 1 Slope (%)	1.3		X Walk 2 Slope (%)	N/A
	X Walk 1 X Slope (%)	0.3		X Walk 2 X Slope (%)	N/A

N/A	Ramp inside XWalk1?	Yes	N/A	Ramp inside XWalk2?	N/A
	Road Slope (%)	N/A	N/A	Clear Space?	N/A
	Road X Slope (%)	N/A	N/A	Clear Space to XWalk (in)	N/A
N/A	Any Obstructions?	N/A	N/A	Storm Grate/Utility Hazard?	N/A
	Obstruction Type			Storm Grate/Utility Type	
		N/A			N/A
			Yes	Surface Condition? (G/P)	Good

Possible Solutions:

**Remove & Replace Entire Ramp.**

Total Cost: \$ 1850.00
