Access Compliance Report

Public Rights-of-Way

(Curb Ramps)

| Intersection ID: N/A | Main Street: E_WOODLAWN_RD | Cross Street: N/A | Location: NW |

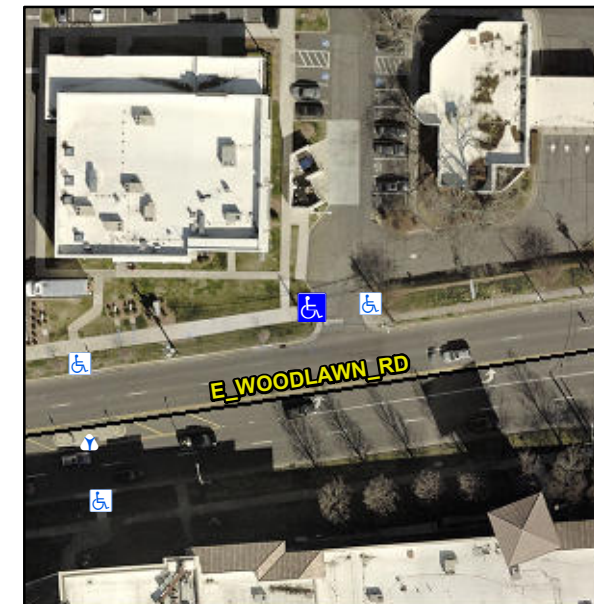
| ADA ID: 775E473B0687 | Ramp Type: Directional1 | Initial Pass/Fail: Fail | Overall Compliance: No |

R304.5.3

| Compliance | Description | Data | Compliance | Description | Data |
|---|---|---|---|---|---|
| No | Ramp XSlope (%) | 2.2 | | | |

Possible Solutions:

Remove & Replace Entire Ramp.
