Access Compliance Report

Public Rights-of-Way

(Curb Ramps)

Intersection ID: 7201	Main Street: PICKERING_DR	Cross Street: W_ROCKY_RIVER_RD	Location: E
ADA ID: 7763D28B782E	Ramp Type: Perp	Initial Pass/Fail: Fail	Overall Compliance: No
			Severity Score: 26.25

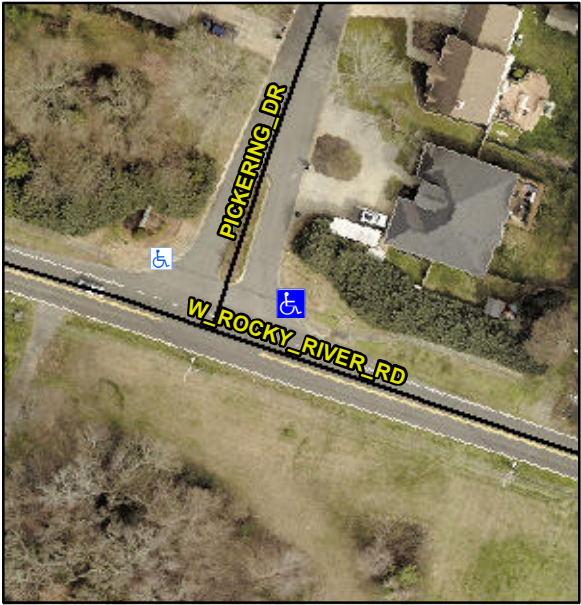
Possible Solutions:		Compliance	Description	Data
	Remove & Replace Entire Ramp.		N/A	Ramp Length (in)	48.0
			Yes	Ramp Width (in)	48.0
			N/A	Flare Type LT	N/A
			N/A	Flare Slope LT (%)	N/A
			N/A	Flare Traversable LT?	N/A
			N/A	Landing Length (in)	N/A
			N/A	Landing Width (in)	N/A
			N/A	Landing Slope (%)	N/A
			N/A	Landing X Slope (%)	N/A
<p>Surveyor Notes:</p> <p>N/A</p> <p>PROW/ADA:</p> <p>Not Found, R304.2.2, R304.5.3</p>			N/A	Flare Type RT	N/A
			N/A	Flare Slope RT (%)	N/A
			N/A	Flare Traversable RT?	N/A
			N/A	DWS Provided?	N/A
			N/A	DWS Contrast?	N/A
			N/A	DWS Length (in)	N/A
			N/A	DWS Full Width?	N/A
			N/A	DWS Offset (in)	N/A
			N/A	Shared Landing?	N/A
			N/A	Gutter Ponding?	N/A
			N/A	Gutter Lip Ht (in)	N/A
			N/A	Painted X Walk1?	No
				X Walk 1 Direction	To NW
			N/A	X Walk 1 Width (in)	N/A
				X Walk 1 Slope (%)	2.4

X Walk 1 X Slope (%)	2.1
			N/A	Ramp inside XWalk1?	N/A
				Road Slope (%)	N/A
				Road X Slope (%)	N/A
			N/A	Any Obstructions?	N/A
				Obstruction Type	
Total Cost:		\$ 1850.00			
			N/A		N/A
			Yes	Surface Condition? (G/P)	Good
