Access Compliance Report

Public Rights-of-Way

(Curb Ramps)

Intersection ID: 10274	Main Street: N_POPLAR_ST	Cross Street: W_24TH_ST	Location: S
ADA ID: 776B61889214	Ramp Type: Perp	Initial Pass/Fail: Fail	Overall Compliance: No
Severity Score: 21.25			
Codes/Mitigation Info/Possible Solution		Field Measurements/Component Compliance

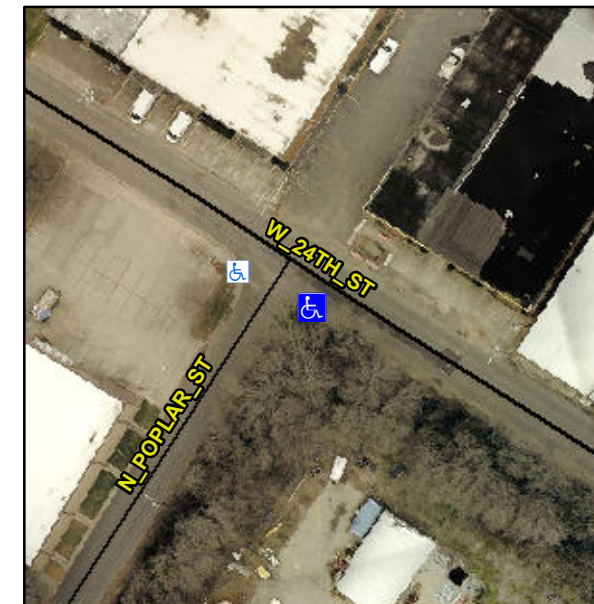
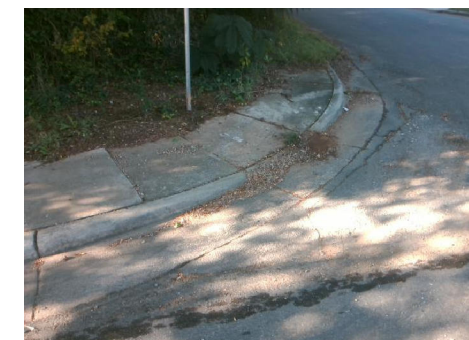
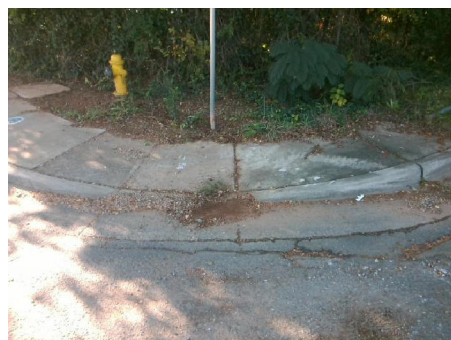
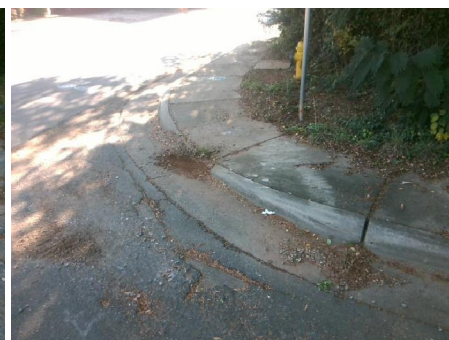
Not Found, R304.5.1, R304.2.2

Compliance	Description	Data	Compliance	Description	Data
N/A	Ramp Length (in)	48.0	No	Ramp Slope (%)	8.8
No	Ramp Width (in)	38.0	Yes	Ramp XSlope (%)	1.1
N/A	Flare Type LT	N/A	N/A	Flare Type RT	N/A
N/A	Flare Slope LT (%)	N/A	N/A	Flare Slope RT (%)	N/A
N/A	Flare Traversable LT?	N/A	N/A	Flare Traversable RT?	N/A
N/A	Landing Length (in)	N/A	N/A	DWS Provided?	N/A
N/A	Landing Width (in)	N/A	N/A	DWS Contrast?	N/A
N/A	Landing Slope (%)	N/A	N/A	DWS Length (in)	N/A
N/A	Landing X Slope (%)	N/A	N/A	DWS Full Width?	N/A
N/A	Landing Curb? (Y/N)	N/A	N/A	DWS Offset (in)	N/A
N/A	Shared Landing?	N/A			
N/A	Gutter Ponding?	N/A	N/A	Gutter Slope (%)	N/A
N/A	Gutter Lip Ht (in)	N/A	N/A	Gutter X Slope (%)	N/A
N/A	Painted X Walk1?	No	N/A	Painted X Walk2?	N/A
	X Walk 1 Direction	To NW		X Walk 2 Direction	N/A
N/A	X Walk 1 Width (in)	N/A	N/A	X Walk 2 Width (in)	N/A
	X Walk 1 Slope (%)	1.1		X Walk 2 Slope (%)	N/A
	X Walk 1 X Slope (%)	1.1		X Walk 2 X Slope (%)	N/A

N/A	Ramp inside XWalk1?	N/A	N/A	Ramp inside XWalk2?	N/A
	Road Slope (%)	N/A	N/A	Clear Space?	N/A
	Road X Slope (%)	N/A	N/A	Clear Space to XWalk (in)	N/A
N/A	Any Obstructions?	N/A	N/A	Storm Grate/Utility Hazard?	N/A
	Obstruction Type			Storm Grate/Utility Type	
		N/A			N/A
			Yes	Surface Condition? (G/P)	Good

Remove & Replace Entire Ramp.

Total Cost: \$ 1850.00
