Access Compliance Report

Public Rights-of-Way

(Curb Ramps)

Intersection ID: 29394	Main Street: AMBERGLADES_LN	Cross Street: GARDENIA_ST	Location: SW
ADA ID: 776FD848A52D	Ramp Type: PerpDiag	Initial Pass/Fail: Fail	Overall Compliance: No
Severity Score: 8.75			
Codes/Mitigation Info/Possible Solution		Field Measurements/Component Compliance

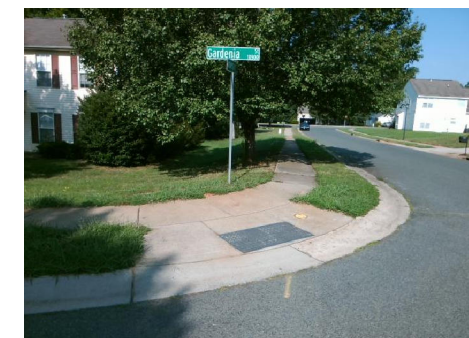
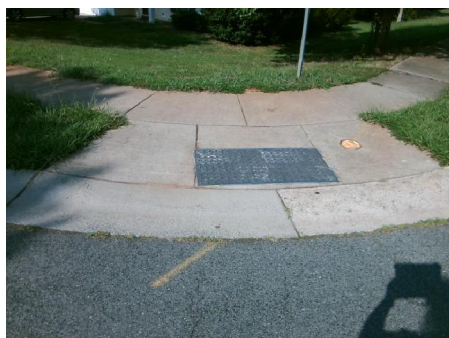
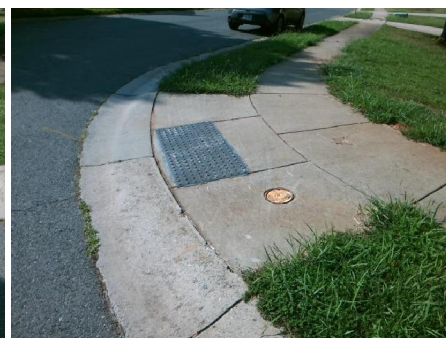
Street 1 Name **GARDENIA ST**
 Stop Condition-Street 2 **StopSign**
 Street 2 Name **AMBERGLADES LN**
 Stop Condition-Street 1 **None**
