Access Compliance Report

Public Rights-of-Way

(Curb Ramps)

| Intersection ID: 28929 | Main Street: WADE_ARDREY_RD | Cross Street: CAMPBELL_HALL_CT | Location: NE |

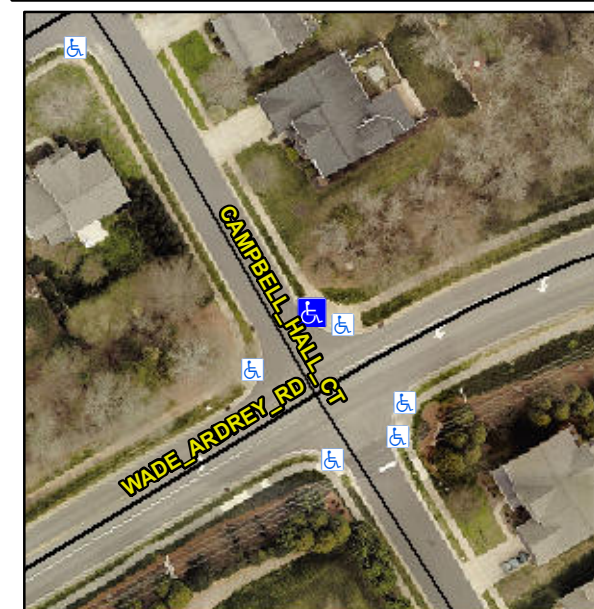
| ADA ID: 77763FCF4C20 | Ramp Type: Perp | Initial Pass/Fail: Fail | Overall Compliance: No |
| Severity Score: 17.5 | | | |

R304.5.1

| Compliance | Description | Data | Compliance | Description | Data |
|---|---|---|---|---|---|
| No | Ramp Width (in) | 33.0 | Yes | Ramp XSlope (%) | 0.4 |

Remove & Replace Entire Ramp.

\$ 1850.00
