# Access Compliance Report

## Public Rights-of-Way

### (Curb Ramps)

| Intersection ID: 10026082 | Main Street: ENDAHVEN_LN | Cross Street: N/A | Location: SW |

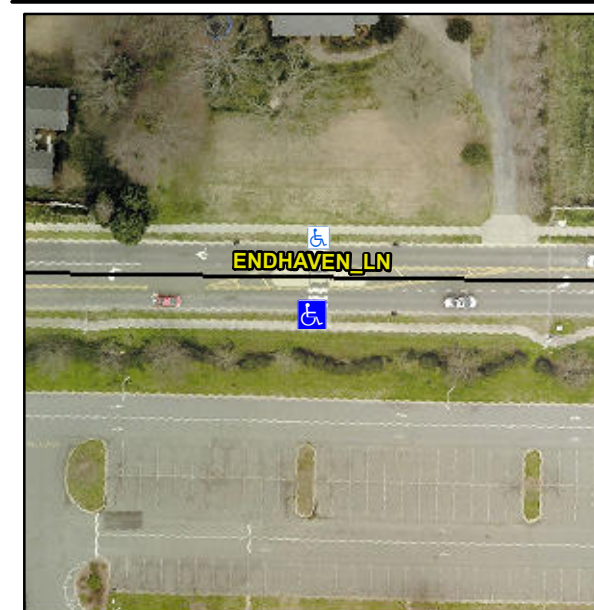
| ADA ID: 777ED0F69990 | Ramp Type: Perp | Initial Pass/Fail: Fail | Overall Compliance: No |
| Severity Score: 13.75 | | | |

**Not Found, R304.2.2, R304.5.3**

| Compliance | Description | Data | Compliance | Description | Data |
|---|---|---|---|---|---|
| N/A | Ramp Length (in) | 101.0 | No | Ramp Slope (%) | 8.6 |
| Yes | Ramp Width (in) | 48.0 | No | Ramp XSlope (%) | 2.3 |

**Remove & Replace Entire Ramp.**

Total Cost: \$ 1850.00
