# Access Compliance Report

## Public Rights-of-Way (Curb Ramps)

| Intersection ID: N/A | Main Street: MATTHEWS_FARM_LN | Cross Street: WOODBINE_WALK_RD | Location: SE |
| ADA ID: 77808D892E8D | Ramp Type: Directional1 | Initial Pass/Fail: Fail | Overall Compliance: No |

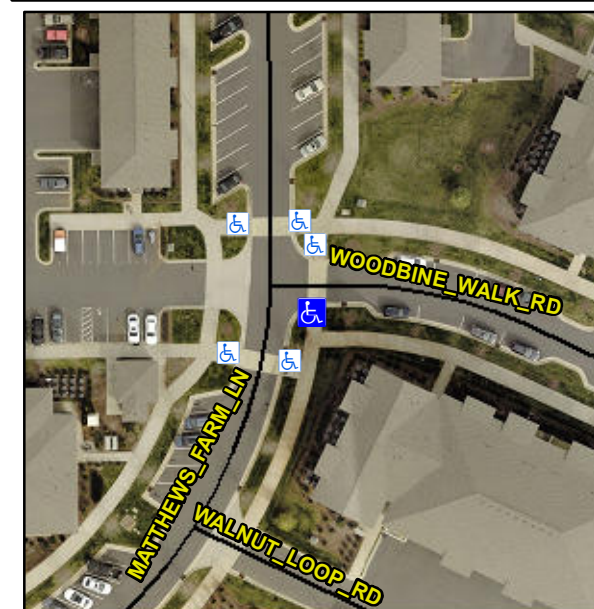
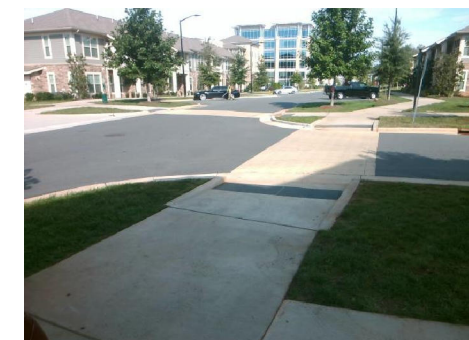
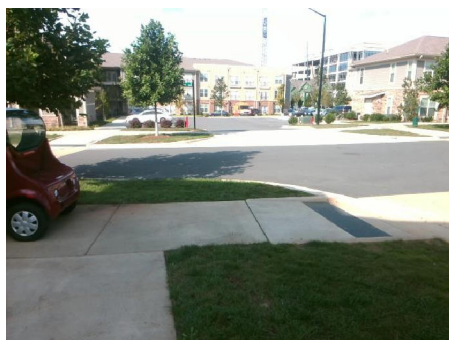
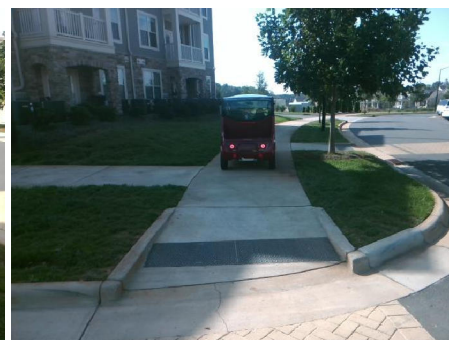
| Severity Score: 1.25 | | | |

**R304.5.3**

| Compliance | Description | Data | Compliance | Description | Data |
|---|---|---|---|---|---|
| No | Ramp XSlope (%) | 2.9 | | | |

**Remove & Replace Entire Ramp.**

\$ 1600.00
