# Access Compliance Report

## Public Rights-of-Way

### (Curb Ramps)

Intersection ID: 11980	Main Street: ALLEN_ST	Cross Street: E_17TH_ST	Location: W
ADA ID: 77848E6ECA86	Ramp Type: Directional1	Initial Pass/Fail: Pass	Overall Compliance: No
Codes/Mitigation Info/Possible Solution			Severity Score: 2.5
			Field Measurements/Component Compliance

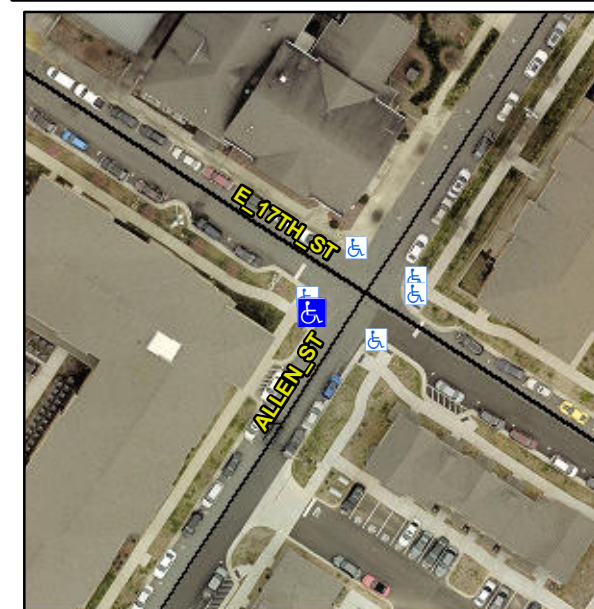
Compliance	Description	Data	Compliance	Description	Data
N/A	Ramp Length (in)	87.0	Yes	Grade Break?	Yes
Yes	Ramp Width (in)	53.0	Yes	Grade Break Slope (%)	3.0
Yes	Ramp Slope (%)	5.8	Yes	Grade Break XSlope (%)	0.3
Yes	Ramp XSlope (%)	1.1			
Yes	Flare Type LT	N/A	Yes	Flare Type RT	N/A
N/A	Flare Slope LT (%)	N/A	N/A	Flare Slope RT (%)	N/A
N/A	Flare Traversable LT?	No	N/A	Flare Traversable RT?	No
Yes	Landing Length (in)	71.0	Yes	DWS Provided?	Yes
Yes	Landing Width (in)	72.0	Yes	DWS Contrast?	Yes
Yes	Landing Slope (%)	1.7	Yes	DWS Length (in)	24.0
Yes	Landing X Slope (%)	1.1	No	DWS Full Width?	No
N/A	Landing Curb? (Y/N)	N/A	Yes	DWS Offset LT (in)	8.5
N/A	Shared Landing?	Yes	No	DWS Offset RT (in)	4.0
Yes	Gutter Ponding?	No	Yes	Gutter Slope (%)	4.5
Yes	Gutter Lip Ht (in)	0.0	Yes	Gutter X Slope (%)	0.0
N/A	Painted X Walk1?	No		Road Slope (%)	4.6
	X Walk 1 Direction	To SE		Road X Slope (%)	1.2
	X Walk 1 Width (in)	N/A		Clear Space?	Yes

X Walk 1 Slope (%)	4.6	N/A	Clear Space to XWalk (in)	N/A
	X Walk 1 X Slope (%)	1.2	Yes	Storm Grate/Utility Hazard?	No
N/A	Ramp inside XWalk1?	N/A		Storm Grate/Utility Type	
Yes	Any Obstructions?	No			N/A
	Obstruction Type		Yes	Surface Condition? (G/P)	Good
			N/A	Curb Slope (%)	2.3

**Remove & Replace Detectable Warning System.**

**R305.1.4, R305.2**

Total Cost: \$ 800.00
