# Access Compliance Report

## Public Rights-of-Way (Curb Ramps)

Intersection ID: 48503	Main Street: KELBURN_LN	Cross Street: CASTLECOVE_RD	Location: NE
ADA ID: 778710FC3B18	Ramp Type: PerpDiag	Initial Pass/Fail: Fail	Overall Compliance: No
Severity Score: 25			
Codes/Mitigation Info/Possible Solution		Field Measurements/Component Compliance

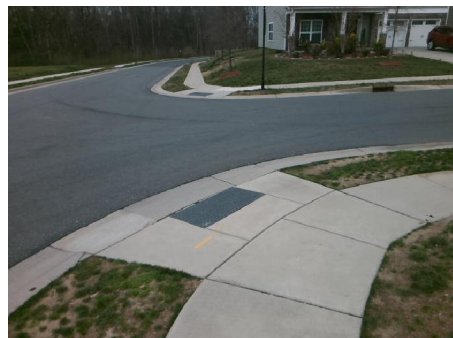
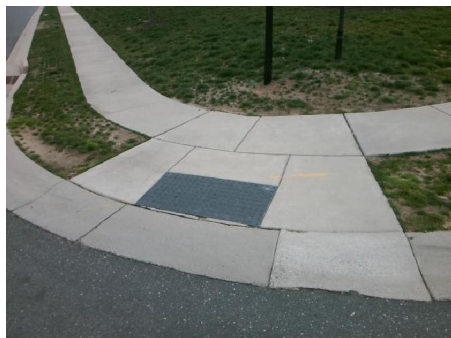
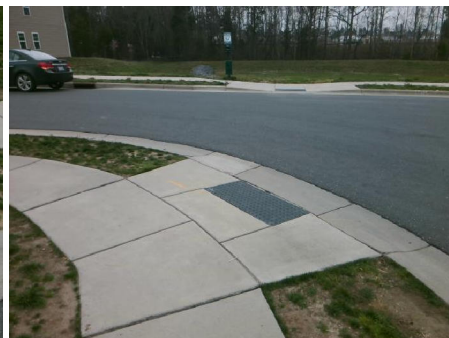
Compliance	Description	Data	Compliance	Description	Data
N/A	Ramp Length (in)	48.0	No	Ramp Slope (%)	8.7
Yes	Ramp Width (in)	48.0	No	Ramp XSlope (%)	5.1
N/A	Flare Type LT	N/A	N/A	Flare Type RT	N/A
N/A	Flare Slope LT (%)	N/A	N/A	Flare Slope RT (%)	N/A
N/A	Flare Traversable LT?	N/A	N/A	Flare Traversable RT?	N/A
N/A	Landing Length (in)	N/A	N/A	DWS Provided?	N/A
N/A	Landing Width (in)	N/A	N/A	DWS Contrast?	N/A
N/A	Landing Slope (%)	N/A	N/A	DWS Length (in)	N/A
N/A	Landing X Slope (%)	N/A	N/A	DWS Full Width?	N/A
N/A	Landing Curb? (Y/N)	N/A	N/A	DWS Offset (in)	N/A
N/A	Shared Landing?	N/A			
N/A	Gutter Ponding?	N/A	N/A	Gutter Slope (%)	N/A
N/A	Gutter Lip Ht (in)	N/A	N/A	Gutter X Slope (%)	N/A
N/A	Painted X Walk1?	No	N/A	Painted X Walk2?	No
	X Walk 1 Direction	To SW		X Walk 2 Direction	To SE
N/A	X Walk 1 Width (in)	N/A	N/A	X Walk 2 Width (in)	N/A
	X Walk 1 Slope (%)	0.1		X Walk 2 Slope (%)	2.6
	X Walk 1 X Slope (%)	2.1		X Walk 2 X Slope (%)	3.1

N/A	Ramp inside XWalk1?	N/A	N/A	Ramp inside XWalk2?	N/A
	Road Slope (%)	4.3	N/A	Clear Space?	N/A
	Road X Slope (%)	1.5	N/A	Clear Space to XWalk (in)	N/A
N/A	Any Obstructions?	N/A	N/A	Storm Grate/Utility Hazard?	N/A
	Obstruction Type			Storm Grate/Utility Type	
		N/A			N/A
		Yes		Surface Condition? (G/P)	Good

**Remove & Replace Curb Ramp With Two New Directional Ramps or Equivalent.**
