Access Compliance Report Public Rights-of-Way (Curb Ramps)

Intersection ID: 10041630 Main Street: WHITEHALL PARK DR **Cross Street: N/A** Location: NE ADA ID: 778C8137E9FE Ramp Type: BlendTrans1 Initial Pass/Fail: Fail **Overall Compliance: No Severity Score:** 8.75

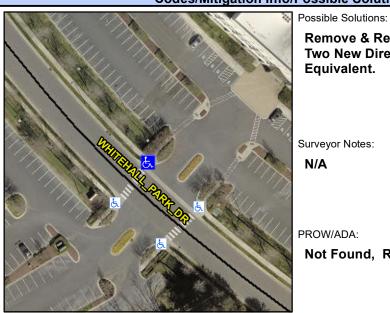
Not Found, R304.5.1

Comp	liance Description	Data	Comp	liance Description	Data
N/A	Ramp Length (in)	48.0	Yes	BlendTrans Slope (%)	4.1
No	Ramp Width (in)	47.0	Yes	BlendTrans XSlope (%)	0.3
N/A	Flare Type LT	N/A	N/A	Flare Type RT	N/A
N/A	Flare Slope LT (%)	N/A	N/A	Flare Slope RT (%)	N/A
N/A	Flare Traversable LT?	N/A	N/A	Flare Traversable RT?	N/A
N/A	Landing Length (in)	N/A	N/A	DWS Provided?	N/A
N/A	Landing Width (in)	N/A	N/A	DWS Contrast?	N/A
N/A	Landing Slope (%)	N/A	N/A	DWS Length (in)	N/A
N/A	Landing X Slope (%)	N/A	N/A	DWS Full Width?	N/A
N/A	Landing Curb? (Y/N)	N/A	N/A	DWS Offset (in)	N/A
N/A	Shared Landing?	N/A			
N/A	Gutter Ponding?	N/A	N/A	Gutter Slope (%)	N/A
N/A	Gutter Lip Ht (in)	N/A	N/A	Gutter X Slope (%)	N/A
N/A	Painted X Walk1?	Yes	N/A	Painted X Walk2?	No
	X Walk 1 Direction	To SW		X Walk 2 Direction	To SE
	X Walk 1 Width (in)	96.0		X Walk 2 Width (in)	N/A
	X Walk 1 Slope (%)	5.6		X Walk 2 Slope (%)	1.0
	X Walk 1 X Slope (%)	0.2		X Walk 2 X Slope (%)	0.2

N/A	Ramp inside XWalk1?	Yes	N/A	Ramp inside XWalk2?	N/A
	Road Slope (%)	2.6		Clear Space?	N/A
	Road X Slope (%)	0.8	N/A	Clear Space to XWalk (in)	N/A
N/A	Any Obstructions?	N/A	N/A	Storm Grate/Utility Hazard?	N/A
	Obstruction Type			Storm Grate/Utility Type	
		N/A			N/A
			Yes	Surface Condition? (G/P)	Good
Alle.			No	Curb Slope (%)	10.1

WHITEHALL PARK DR Street 1 Name Stop Condition-Street 1 None Street 2 Name N/A Stop Condition-Street 2 StopSign **Remove & Replace Curb Ramp With** Two New Directional Ramps or Equivalent.
