Access Compliance Report Public Rights-of-Way (Curb Ramps)

Intersection ID: 25829 Main Street: GREYSON_RIDGE_DR Cross Street: HIGH_RIDGE_RD Location: SE

ADA ID: 778CC482101F Ramp Type: PerpDiag Initial Pass/Fail: Fail Overall Compliance: No Severity Score: 13.75

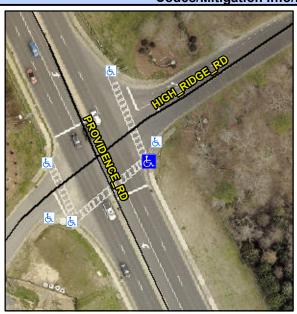
Not Found, R304.2.2

Compliance Description Data Compliance Description Data No N/A Ramp Length (in) 73.0 Ramp Slope (%) 9.1 Yes Ramp XSlope (%) Yes Ramp Width (in) 48.0 4.7 N/A N/A Flare Type LT N/A Flare Type RT N/A N/A N/A N/A Flare Slope RT (%) N/A Flare Slope LT (%) N/A Flare Traversable LT? N/A N/A Flare Traversable RT? N/A N/A N/A N/A **DWS Provided?** N/A Landing Length (in) N/A Landing Width (in) N/A N/A **DWS Contrast?** N/A N/A N/A N/A Landing Slope (%) DWS Length (in) N/A N/A Landing X Slope (%) N/A N/A DWS Full Width? N/A N/A Landing Curb? (Y/N) N/A N/A DWS Offset (in) N/A N/A N/A Shared Landing? N/A Gutter Ponding? N/A N/A Gutter Slope (%) N/A N/A Gutter Lip Ht (in) N/A N/A Gutter X Slope (%) N/A N/A Painted X Walk1? Yes N/A Painted X Walk2? Yes X Walk 1 Direction To N X Walk 2 Direction To W N/A 75.0 82.0 X Walk 1 Width (in) X Walk 2 Width (in) X Walk 1 Slope (%) 0.8 X Walk 2 Slope (%) 7.0 X Walk 1 X Slope (%) 4.3 X Walk 2 X Slope (%) 1.9 N/A N/A Ramp inside XWalk2? Ramp inside XWalk1? Yes Yes Road Slope (%) 6.1 N/A Clear Space? N/A N/A Road X Slope (%) 3.1 Clear Space to XWalk (in) N/A N/A N/A N/A Any Obstructions? Storm Grate/Utility Hazard? N/A **Obstruction Type** Storm Grate/Utility Type N/A N/A Yes Surface Condition? (G/P) Good

Remove & Replace Curb Ramp With Two New Directional Ramps or Equivalent.

Total Cost: \$ 3200.00
