Access Compliance Report

Public Rights-of-Way

(Curb Ramps)

| Intersection ID: 30010 | Main Street: BACKWATER_DR | Cross Street: SMOOTHSTONE_LN | Location: SE |

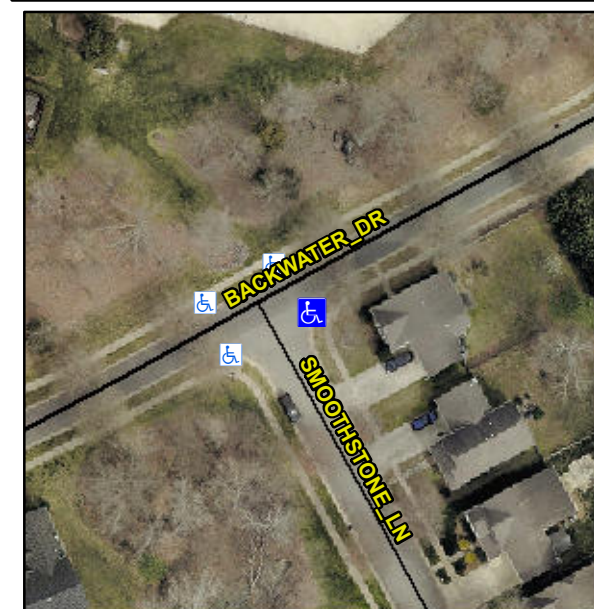
Not Found, R304.5.1, R304.5.3

| Compliance | Description | Data | Compliance | Description | Data |
|---|---|---|---|---|---|
| N/A | Ramp Length (in) | 75.0 | Yes | Ramp Slope (%) | 7.5 |
| No | Ramp Width (in) | 46.5 | No | Ramp XSlope (%) | 7.3 |

Remove & Replace Curb Ramp With Two New Directional Ramps or Equivalent.
