# Access Compliance Report

## Public Rights-of-Way

### (Curb Ramps)

| Intersection ID: 50544 | Main Street: ALCEA_ST | Cross Street: CAYENNE_DR | Location: | N |

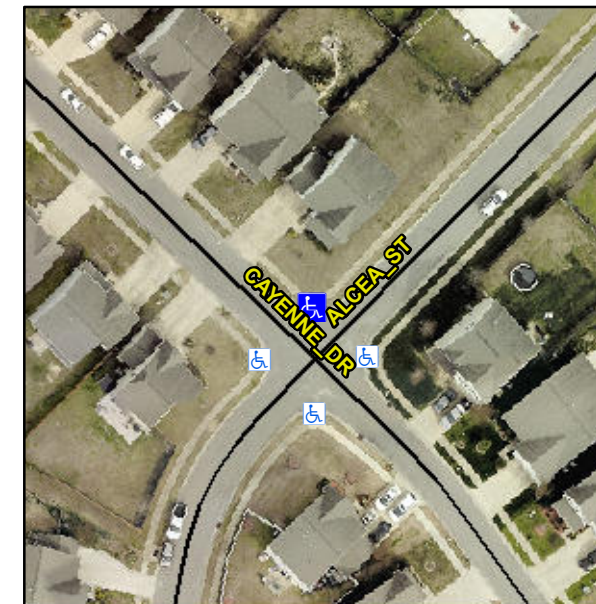
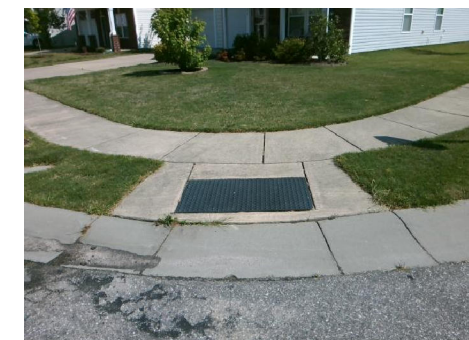
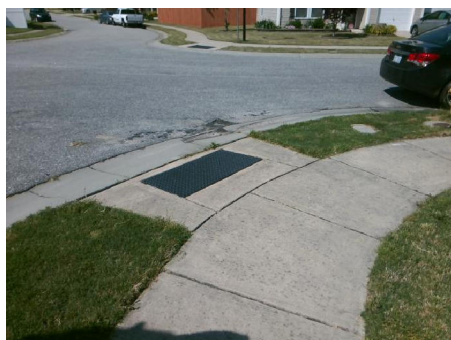
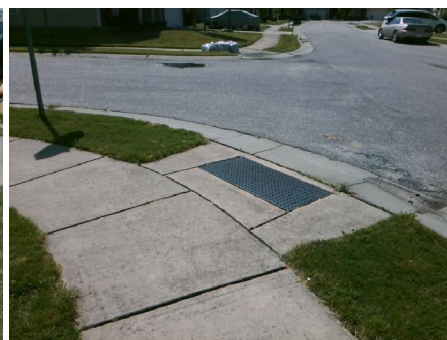
| ADA ID: 779CC643B7D7 | Ramp Type: PerpDiag | Initial Pass/Fail: Fail | Overall Compliance: No | Severity Score: 8.75 |

**Not Found, R304.5.1**

| Compliance | Description | Data | Compliance | Description | Data |
|---|---|---|---|---|---|
| No | Ramp Width (in) | 46.0 | Yes | Ramp XSlope (%) | 1.6 |

**Remove & Replace Curb Ramp With Two New Directional Ramps or Equivalent.**
