# Access Compliance Report

## Public Rights-of-Way

### (Curb Ramps)

Intersection ID: 12425	Main Street: W_MOREHEAD_ST	Cross Street: ELDRIDGE_ST	Location: NE
ADA ID: 77A004453DB7	Ramp Type: PerpDiag	Initial Pass/Fail: Fail	Overall Compliance: No
Codes/Mitigation Info/Possible Solution		Field Measurements/Component Compliance	
Severity Score: 12.5

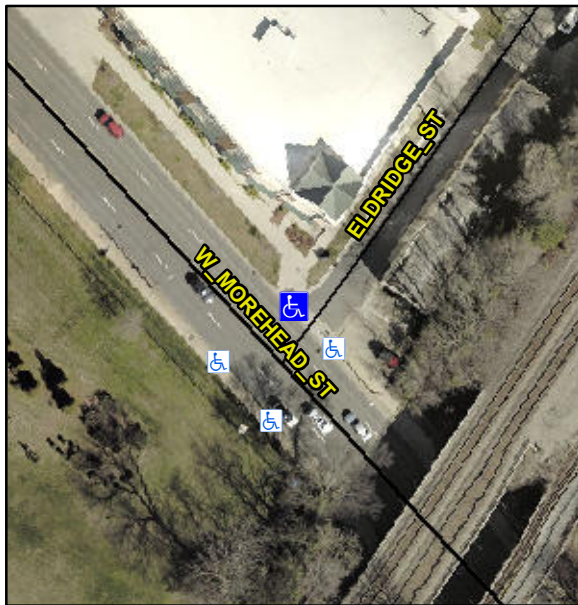
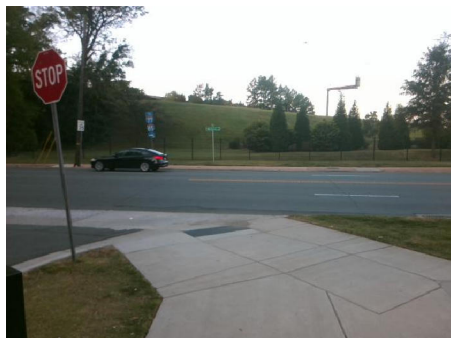
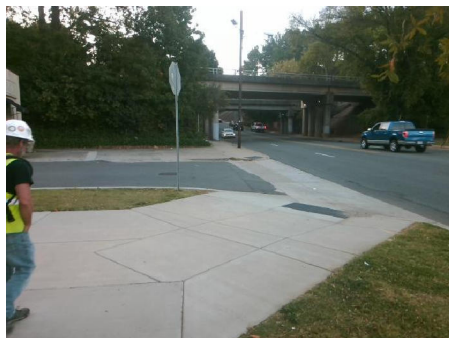
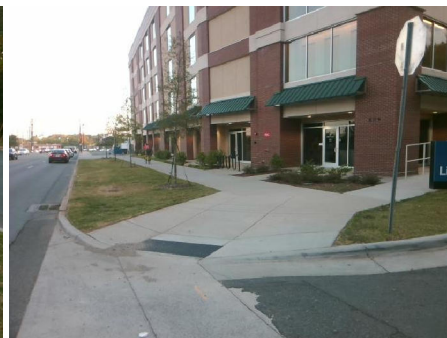
Compliance	Description	Data	Compliance	Description	Data
N/A	Ramp Length (in)	112.0	No	Ramp Slope (%)	9.7
Yes	Ramp Width (in)	60.0	Yes	Ramp XSlope (%)	1.1
N/A	Flare Type LT	N/A	N/A	Flare Type RT	N/A
N/A	Flare Slope LT (%)	N/A	N/A	Flare Slope RT (%)	N/A
N/A	Flare Traversable LT?	N/A	N/A	Flare Traversable RT?	N/A
N/A	Landing Length (in)	N/A	N/A	DWS Provided?	N/A
N/A	Landing Width (in)	N/A	N/A	DWS Contrast?	N/A
N/A	Landing Slope (%)	N/A	N/A	DWS Length (in)	N/A
N/A	Landing X Slope (%)	N/A	N/A	DWS Full Width?	N/A
N/A	Landing Curb? (Y/N)	N/A	N/A	DWS Offset (in)	N/A
N/A	Shared Landing?	N/A			
N/A	Gutter Ponding?	N/A	N/A	Gutter Slope (%)	N/A
N/A	Gutter Lip Ht (in)	N/A	N/A	Gutter X Slope (%)	N/A
N/A	Painted X Walk1?	No	N/A	Painted X Walk2?	No
	X Walk 1 Direction	To SW		X Walk 2 Direction	To SE
N/A	X Walk 1 Width (in)	N/A	N/A	X Walk 2 Width (in)	N/A
	X Walk 1 Slope (%)	4.7		X Walk 2 Slope (%)	1.0
	X Walk 1 X Slope (%)	0.1		X Walk 2 X Slope (%)	0.8

N/A	Ramp inside XWalk1?	N/A	N/A	Ramp inside XWalk2?	N/A
	Road Slope (%)	1.2	N/A	Clear Space?	N/A
	Road X Slope (%)	0.1	N/A	Clear Space to XWalk (in)	N/A
N/A	Any Obstructions?	N/A	N/A	Storm Grate/Utility Hazard?	N/A
	Obstruction Type			Storm Grate/Utility Type	
		N/A			N/A
			Yes	Surface Condition? (G/P)	Good

**Remove & Replace Curb Ramp With Two New Directional Ramps or Equivalent.**

**Not Found, R304.2.2**
