Access Compliance Report

Public Rights-of-Way

(Curb Ramps)

Intersection ID: N/A	Main Street: STEPHENDALE DR	Cross Street: HOOKSTON_LN	Location: NE
ADA ID: 77A7AFB8A83D	Ramp Type: Directional1	Initial Pass/Fail: Fail	Overall Compliance: No
Severity Score: 8.75			
Codes/Mitigation Info/Possible Solution		Field Measurements/Component Compliance

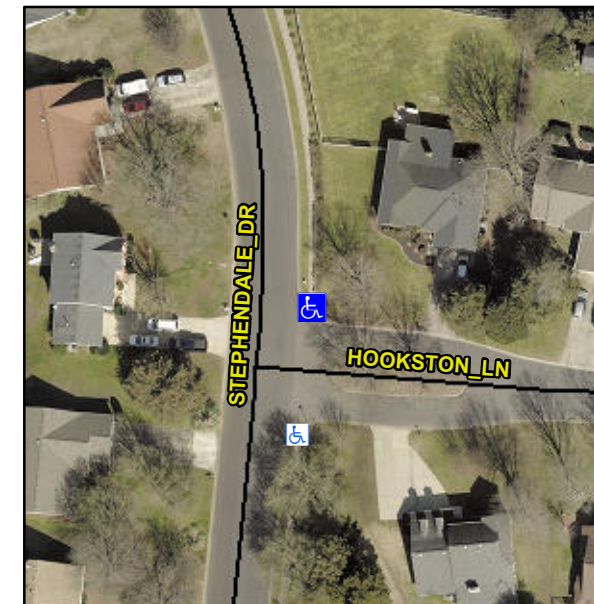
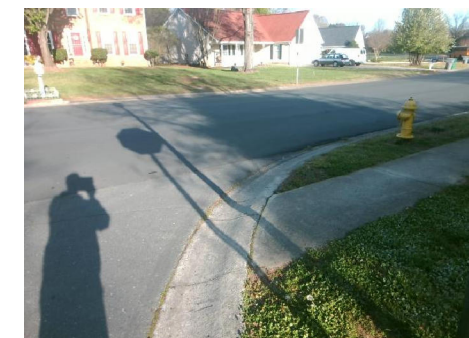
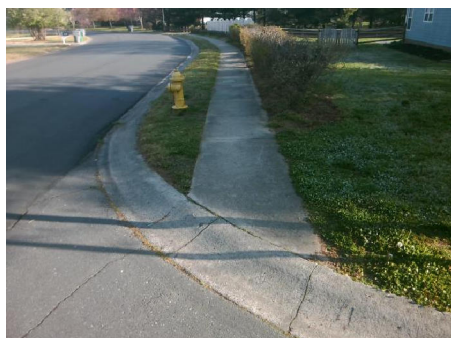
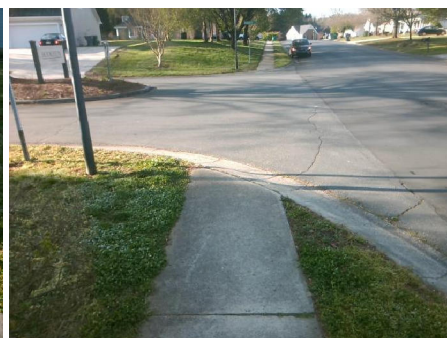
Compliance	Description	Data	Compliance	Description	Data
N/A	Ramp Length (in)	77.0	N/A	Grade Break?	N/A
No	Ramp Width (in)	46.0	N/A	Grade Break Slope (%)	0.0
Yes	Ramp Slope (%)	0.6	N/A	Grade Break XSlope (%)	0.0
Yes	Ramp XSlope (%)	1.8			
N/A	Flare Type LT	N/A	N/A	Flare Type RT	N/A
N/A	Flare Slope LT (%)	N/A	N/A	Flare Slope RT (%)	0.0
N/A	Flare Traversable LT?	N/A	N/A	Flare Traversable RT?	N/A
N/A	Landing Length (in)	0.0	N/A	DWS Provided?	N/A
N/A	Landing Width (in)	0.0	N/A	DWS Contrast?	N/A
N/A	Landing Slope (%)	0.0	N/A	DWS Length (in)	N/A
N/A	Landing X Slope (%)	0.0	N/A	DWS Full Width?	N/A
N/A	Landing Curb? (Y/N)	N/A	N/A	DWS Offset LT (in)	N/A
N/A	Shared Landing?	N/A	N/A	DWS Offset RT (in)	N/A
N/A	Gutter Ponding?	0.0	N/A	Gutter Slope (%)	N/A
N/A	Gutter Lip Ht (in)	0.0	N/A	Gutter X Slope (%)	N/A
N/A	Painted X Walk1?	No		Road Slope (%)	1.0
	X Walk 1 Direction	To S		Road X Slope (%)	0.1
	X Walk 1 Width (in)	N/A		Clear Space?	N/A

X Walk 1 Slope (%)	1.0	N/A	Clear Space to XWalk (in)	N/A
	X Walk 1 X Slope (%)	0.1	N/A	Storm Grate/Utility Hazard?	N/A
N/A	Ramp inside XWalk1?	N/A		Storm Grate/Utility Type	
N/A	Any Obstructions?	N/A			N/A
	Obstruction Type		Yes	Surface Condition? (G/P)	Good
			N/A	Curb Slope (%)	31.6

Possible Solutions:

Remove & Replace Entire Ramp.

R304.5.1

\$ 1600.00
