Access Compliance Report

Public Rights-of-Way

(Curb Ramps)

Intersection ID: 10584	Main Street: COXE_AV	Cross Street: S_TURNER_AV	Location: SE
ADA ID: 77AA05309B8C	Ramp Type: BlendTrans1	Initial Pass/Fail: Fail	Overall Compliance: No
		Severity Score: 25

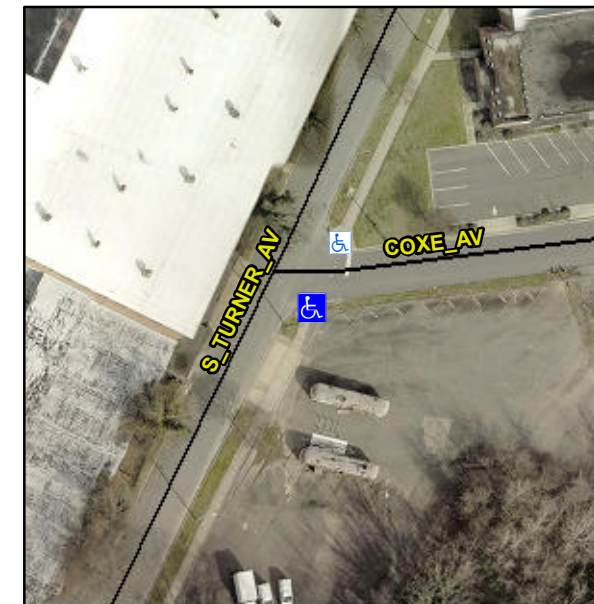
Not Found, R304.5.3

Compliance	Description	Data	Compliance	Description	Data
N/A	Ramp Length (in)	74.0	Yes	BlendTrans Slope (%)	4.2
Yes	Ramp Width (in)	57.0	No	BlendTrans XSlope (%)	7.8
N/A	Flare Type LT	N/A	N/A	Flare Type RT	N/A
N/A	Flare Slope LT (%)	N/A	N/A	Flare Slope RT (%)	N/A
N/A	Flare Traversable LT?	N/A	N/A	Flare Traversable RT?	N/A
N/A	Landing Length (in)	N/A	N/A	DWS Provided?	N/A
N/A	Landing Width (in)	N/A	N/A	DWS Contrast?	N/A
N/A	Landing Slope (%)	N/A	N/A	DWS Length (in)	N/A
N/A	Landing X Slope (%)	N/A	N/A	DWS Full Width?	N/A
N/A	Landing Curb? (Y/N)	N/A	N/A	DWS Offset (in)	N/A
N/A	Shared Landing?	N/A			
N/A	Gutter Ponding?	N/A	N/A	Gutter Slope (%)	N/A
N/A	Gutter Lip Ht (in)	N/A	N/A	Gutter X Slope (%)	N/A
N/A	Painted X Walk1?	No	N/A	Painted X Walk2?	N/A
	X Walk 1 Direction	To NE		X Walk 2 Direction	N/A
	X Walk 1 Width (in)	N/A		X Walk 2 Width (in)	N/A
	X Walk 1 Slope (%)	5.4		X Walk 2 Slope (%)	N/A
	X Walk 1 X Slope (%)	4.4		X Walk 2 X Slope (%)	N/A

N/A	Ramp inside XWalk1?	N/A	N/A	Ramp inside XWalk2?	N/A
	Road Slope (%)	4.4		Clear Space?	N/A
	Road X Slope (%)	5.4	N/A	Clear Space to XWalk (in)	N/A
N/A	Any Obstructions?	N/A	N/A	Storm Grate/Utility Hazard?	N/A
	Obstruction Type			Storm Grate/Utility Type	
		N/A			N/A
			Yes	Surface Condition? (G/P)	Good
			No	Curb Slope (%)	5.1

Possible Solutions:

Remove & Replace Curb Ramp With Two New Directional Ramps or Equivalent.
