Access Compliance Report Public Rights-of-Way (Curb Ramps)

Intersection ID: 10024061 Main Street: CORPORATE_CENTER_DR Cross Street: N/A Location: SE

ADA ID: 77BB8D2B32C9 Ramp Type: Perp Initial Pass/Fail: Fail Overall Compliance: No Severity Score: 46.25

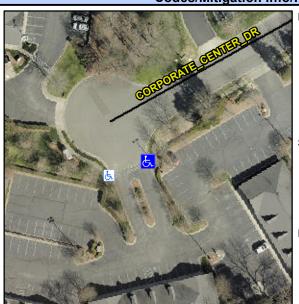
Not Found, R304.5.1, R304.2.2, R304.5.3

Field Measurements/Component Compliance					
Comp	liance Description	Data	Comp	liance Description	Data
N/A	Ramp Length (in)	93.0	No	Ramp Slope (%)	9.4
No	Ramp Width (in)	45.0	No	Ramp XSlope (%)	9.1
N/A	Flare Type LT	N/A	N/A	Flare Type RT	N/A
N/A	Flare Slope LT (%)	N/A	N/A	Flare Slope RT (%)	N/A
N/A	Flare Traversable LT?	N/A	N/A	Flare Traversable RT?	N/A
N/A	Landing Length (in)	N/A	N/A	DWS Provided?	N/A
N/A	Landing Width (in)	N/A	N/A	DWS Contrast?	N/A
N/A	Landing Slope (%)	N/A	N/A	DWS Length (in)	N/A
N/A	Landing X Slope (%)	N/A	N/A	DWS Full Width?	N/A
N/A	Landing Curb? (Y/N)	N/A	N/A	DWS Offset (in)	N/A
N/A	Shared Landing?	N/A			
N/A	Gutter Ponding?	N/A	N/A	Gutter Slope (%)	N/A
N/A	Gutter Lip Ht (in)	N/A	N/A	Gutter X Slope (%)	N/A
N/A	Painted X Walk1?	Yes	N/A	Painted X Walk2?	N/A
	X Walk 1 Direction	To W		X Walk 2 Direction	N/A
N/A	X Walk 1 Width (in)	56.0	N/A	X Walk 2 Width (in)	N/A
	X Walk 1 Slope (%)	0.6		X Walk 2 Slope (%)	N/A

X Walk 1 X Slope (%)	3.6		X Walk 2 X Slope (%)	N/A
N/A	Ramp inside XWalk1?	Yes	N/A	Ramp inside XWalk2?	N/A
	Road Slope (%)	N/A	N/A	Clear Space?	N/A
	Road X Slope (%)	N/A	N/A	Clear Space to XWalk (in)	N/A
N/A	Any Obstructions?	N/A	N/A	Storm Grate/Utility Hazard?	N/A
	Obstruction Type			Storm Grate/Utility Type	
		N/A			N/A
			Yes	Surface Condition? (G/P)	Good
APPRIL TO S	VSUNVS CONTRACTOR VSU VSI A

Possible Solutions:

Remove & Replace Entire Ramp.
