Access Compliance Report

Public Rights-of-Way

(Curb Ramps)

Intersection ID: 15126	Main Street: DOMINO_CT	Cross Street: MONROE_RD	Location: W
ADA ID: 77BCE1D0B662	Ramp Type: Para	Initial Pass/Fail: Fail	Overall Compliance: No
Severity Score: 13.75			
Codes/Mitigation Info/Possible Solution		Field Measurements/Component Compliance

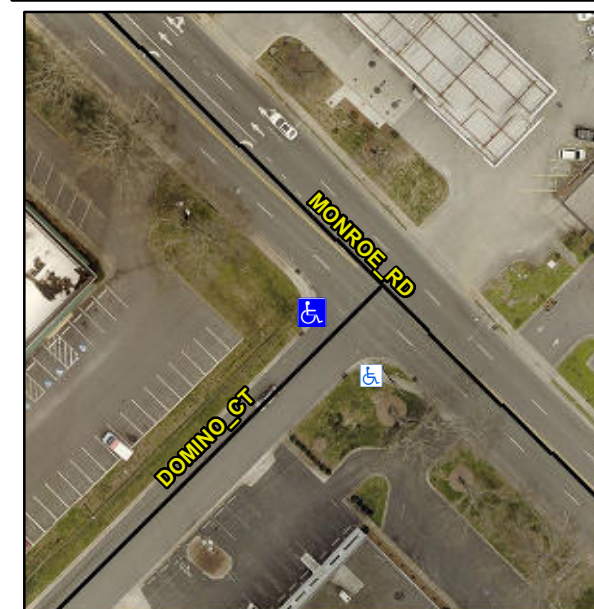
RT RP < 5%, CURB LIP 0.5

R304.3.2, R304.5.3

Compliance	Description	Data	Compliance	Description	Data
N/A	Ramp Length LT (in)	35.0	N/A	Ramp Length RT (in)	51.0
Yes	Ramp Width LT (in)	61.0	Yes	Ramp Width RT (in)	59.5
No	Ramp Slope LT (%)	9.3	Yes	Ramp Slope RT (%)	4.6
Yes	Ramp XSlope LT (%)	1.0	No	Ramp XSlope RT (%)	2.3
N/A	Landing Length (in)	N/A	N/A	DWS Provided?	N/A
N/A	Landing Width (in)	N/A	N/A	DWS Contrast?	N/A
N/A	Landing Slope (%)	N/A	N/A	DWS Length (in)	N/A
N/A	Landing X Slope (%)	N/A	N/A	DWS Full Width?	N/A
N/A	Landing Curb? (Y/N)	N/A	N/A	DWS Offset (in)	N/A
N/A	Shared Landing?	N/A			
N/A	Gutter Ponding?	N/A	N/A	Gutter Slope (%)	N/A
N/A	Gutter Lip Ht (in)	N/A	N/A	Gutter X Slope (%)	N/A
N/A	Painted X Walk1?	No	N/A	Painted X Walk2?	N/A
	X Walk 1 Direction	To SE		X Walk 2 Direction	N/A
N/A	X Walk 1 Width (in)	N/A	N/A	X Walk 2 Width (in)	N/A
	X Walk 1 Slope (%)	4.6		X Walk 2 Slope (%)	N/A
	X Walk 1 X Slope (%)	3.1		X Walk 2 X Slope (%)	N/A
N/A	Ramp inside XWalk1?	N/A	N/A	Ramp inside XWalk2?	N/A

Road Slope (%)	N/A	N/A	Clear Space?	N/A
	Road X Slope (%)	N/A	N/A	Clear Space to XWalk (in)	N/A
N/A	Any Obstructions?	N/A	N/A	Storm Grate/Utility Hazard?	N/A
	Obstruction Type			Storm Grate/Utility Type	
		N/A			N/A
			Yes	Surface Condition? (G/P)	Good
			N/A	Curb Slope (%)	9.7

Possible Solutions:

Remove & Replace Entire Ramp.
