# Access Compliance Report

## Public Rights-of-Way

### (Curb Ramps)

Intersection ID: 9446	Main Street: HIGHLAKE_DR	Cross Street: MALIBU_DR	Location: SW
ADA ID: 77BE7F3D777F	Ramp Type: BlendTrans1	Initial Pass/Fail: Fail	Overall Compliance: No
		Severity Score: 25

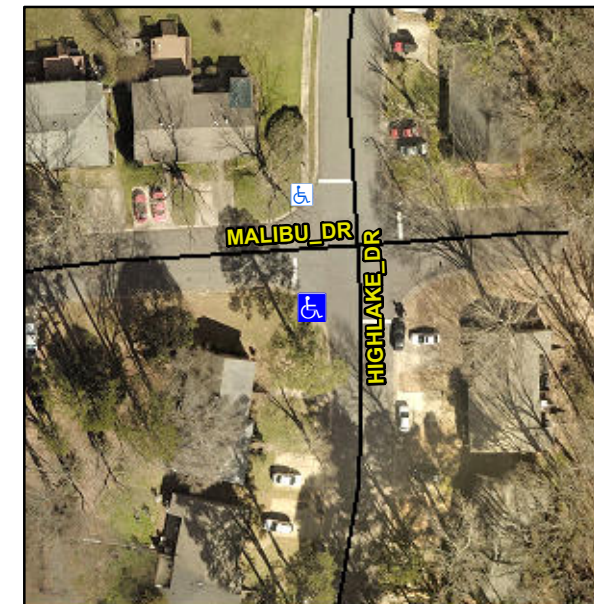
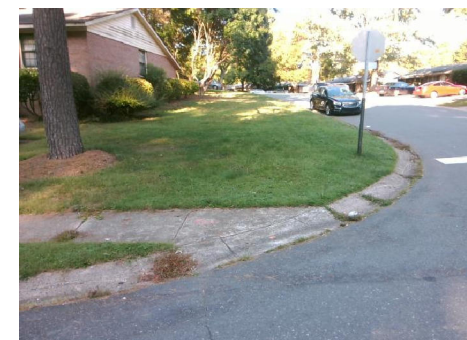
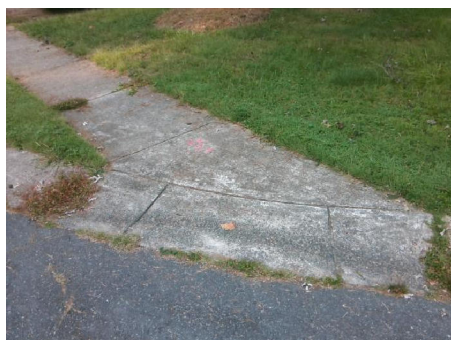
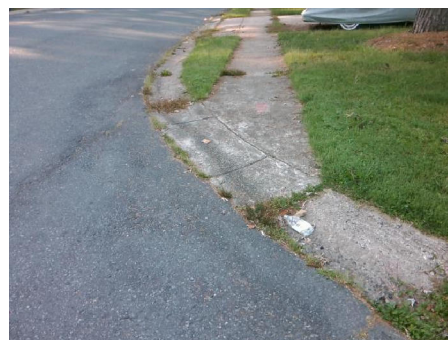
**Not Found, R304.5.3**

Compliance	Description	Data	Compliance	Description	Data
N/A	Ramp Length (in)	58.0	Yes	BlendTrans Slope (%)	0.9
Yes	Ramp Width (in)	48.0	No	BlendTrans XSlope (%)	7.2
N/A	Flare Type LT	N/A	N/A	Flare Type RT	N/A
N/A	Flare Slope LT (%)	N/A	N/A	Flare Slope RT (%)	N/A
N/A	Flare Traversable LT?	N/A	N/A	Flare Traversable RT?	N/A
N/A	Landing Length (in)	N/A	N/A	DWS Provided?	N/A
N/A	Landing Width (in)	N/A	N/A	DWS Contrast?	N/A
N/A	Landing Slope (%)	N/A	N/A	DWS Length (in)	N/A
N/A	Landing X Slope (%)	N/A	N/A	DWS Full Width?	N/A
N/A	Landing Curb? (Y/N)	N/A	N/A	DWS Offset (in)	N/A
N/A	Shared Landing?	N/A			
N/A	Gutter Ponding?	N/A	N/A	Gutter Slope (%)	N/A
N/A	Gutter Lip Ht (in)	N/A	N/A	Gutter X Slope (%)	N/A
N/A	Painted X Walk1?	No	N/A	Painted X Walk2?	N/A
	X Walk 1 Direction	To N		X Walk 2 Direction	N/A
	X Walk 1 Width (in)	N/A		X Walk 2 Width (in)	N/A
	X Walk 1 Slope (%)	4.0		X Walk 2 Slope (%)	N/A
	X Walk 1 X Slope (%)	3.4		X Walk 2 X Slope (%)	N/A

N/A	Ramp inside XWalk1?	N/A	N/A	Ramp inside XWalk2?	N/A
	Road Slope (%)	3.4		Clear Space?	N/A
	Road X Slope (%)	4.0	N/A	Clear Space to XWalk (in)	N/A
N/A	Any Obstructions?	N/A	N/A	Storm Grate/Utility Hazard?	N/A
	Obstruction Type			Storm Grate/Utility Type	
		N/A			N/A
			Yes	Surface Condition? (G/P)	Good
			No	Curb Slope (%)	11.6

**Remove & Replace Curb Ramp With Two New Directional Ramps or Equivalent.**

Total Cost: \$ 3200.00
