# Access Compliance Report

## Public Rights-of-Way

### (Curb Ramps)

| Intersection ID: 51478 | Main Street: BENDERLOCH_DR | Cross Street: MEADOW_BOTTOM_RD | Location: W |

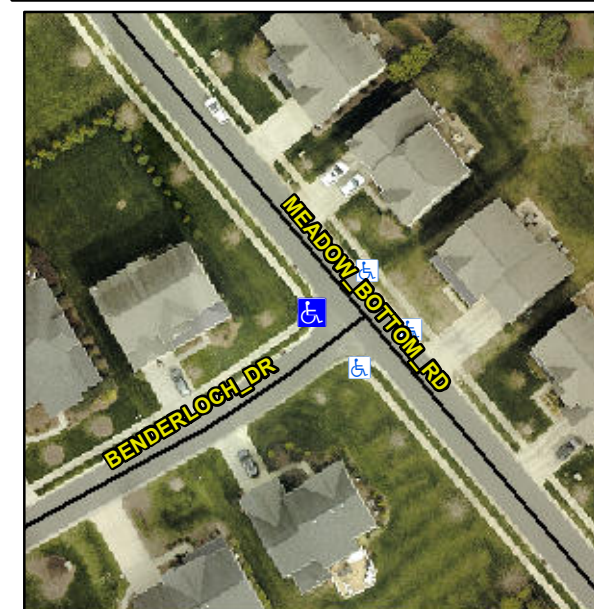
**Not Found, R304.5.3, R304.2.2-Perp, R304.3.2-Para, R305.2**

| Compliance | Description | Data | Compliance | Description | Data |
|---|---|---|---|---|---|
| Yes | Ramp Width (in) | 48.0 | No | Ramp XSlope (%) | 3.4 |
| No | Landing Slope (%) | 2.1 | Yes | DWS Length (in) | 24.0 |
| No | Landing X Slope (%) | 3.0 | Yes | DWS Full Width? | Yes |
| N/A | Landing Curb? (Y/N) | No | No | DWS Offset (in) | 3.0 |
| Yes | Gutter Lip Ht (in) | 0.0 | No | Gutter X Slope (%) | 2.7 |

**Remove & Replace Curb Ramp With Two New Directional Ramps or Equivalent. Remove & Replace Gutter.**

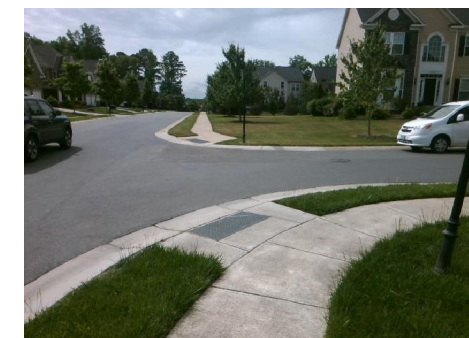
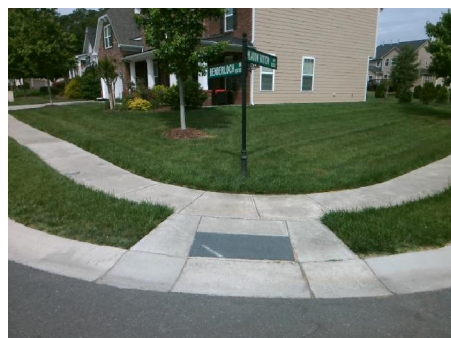
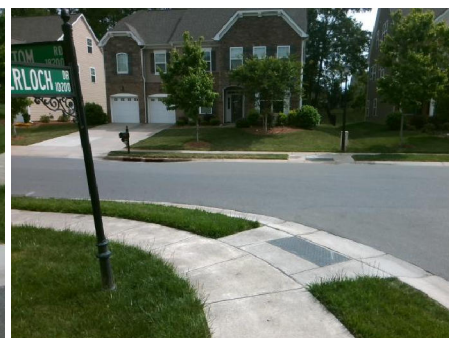
| Compliance | Description | Data | Compliance | Description | Data |
|---|---|---|---|---|---|
| | | | Yes | Surface Condition? (G/P) | Good |
