Access Compliance Report Public Rights-of-Way (Curb Ramps)

Intersection ID: 53927 Main Street: PRESTON_KNOLL_LN Cross Street: BRITTONDALE_LN Location: N

ADA ID: 77C124E2C722 Ramp Type: PerpDiag Initial Pass/Fail: Fail Overall Compliance: No Severity Score: 10

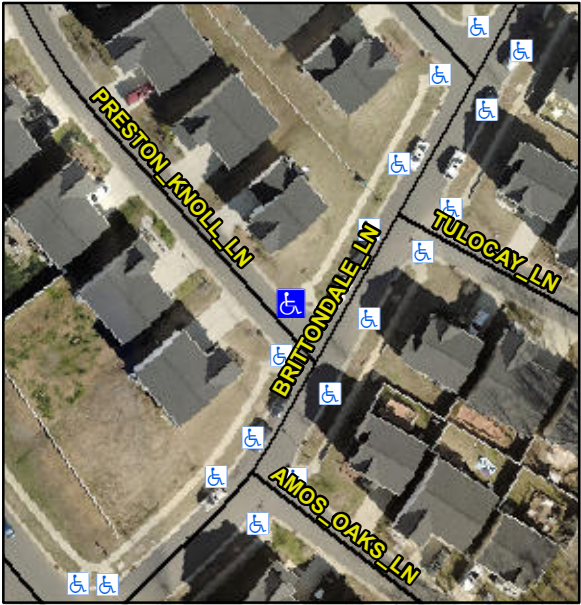
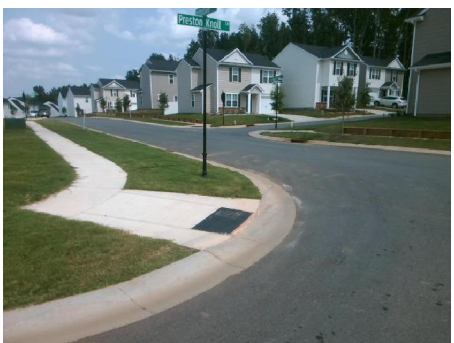
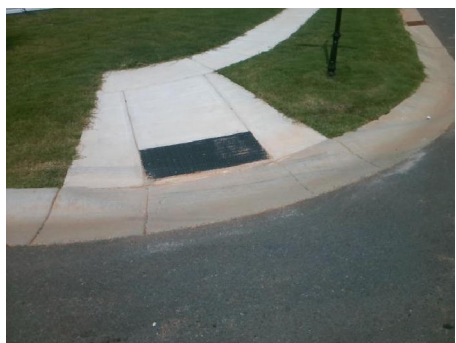
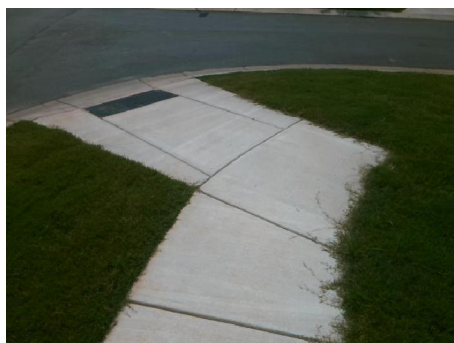
PROW/ADA:
Not Found, R304.5.1, R304.5.3

Compliance	Description	Data	Compliance	Description	Data
N/A	Ramp Length (in)	104.0	Yes	Ramp Slope (%)	5.4
No	Ramp Width (in)	47.0	No	Ramp XSlope (%)	2.1
N/A	Flare Type LT	N/A	N/A	Flare Type RT	N/A
N/A	Flare Slope LT (%)	N/A	N/A	Flare Slope RT (%)	N/A
N/A	Flare Traversable LT?	N/A	N/A	Flare Traversable RT?	N/A
N/A	Landing Length (in)	N/A	N/A	DWS Provided?	N/A
N/A	Landing Width (in)	N/A	N/A	DWS Contrast?	N/A
N/A	Landing Slope (%)	N/A	N/A	DWS Length (in)	N/A
N/A	Landing X Slope (%)	N/A	N/A	DWS Full Width?	N/A
N/A	Landing Curb? (Y/N)	N/A	N/A	DWS Offset (in)	N/A
N/A	Shared Landing?	N/A			
N/A	Gutter Ponding?	N/A	N/A	Gutter Slope (%)	N/A
N/A	Gutter Lip Ht (in)	N/A	N/A	Gutter X Slope (%)	N/A
N/A	Painted X Walk1?	No	N/A	Painted X Walk2?	No
	X Walk 1 Direction	To SW		X Walk 2 Direction	To SE
N/A	X Walk 1 Width (in)	N/A	N/A	X Walk 2 Width (in)	N/A
	X Walk 1 Slope (%)	3.0		X Walk 2 Slope (%)	6.7
	X Walk 1 X Slope (%)	4.1		X Walk 2 X Slope (%)	3.6

N/A	Ramp inside XWalk1?	N/A	N/A	Ramp inside XWalk2?	N/A
	Road Slope (%)	1.2	N/A	Clear Space?	N/A
	Road X Slope (%)	6.7	N/A	Clear Space to XWalk (in)	N/A
N/A	Any Obstructions?	N/A	N/A	Storm Grate/Utility Hazard?	N/A
	Obstruction Type			Storm Grate/Utility Type	
		N/A			N/A
			Yes	Surface Condition? (G/P)	Good

Possible Solutions:
Remove & Replace Curb Ramp With Two New Directional Ramps or Equivalent.
