Access Compliance Report

Public Rights-of-Way

(Curb Ramps)

Intersection ID: 5526	Main Street: COLLINS-AIKMAN_DR	Cross Street: UNIVERSITY_CENTER_BV	Location: NE
ADA ID: 77D37EB719BE	Ramp Type: Directional1	Initial Pass/Fail: Fail	Overall Compliance: No
Codes/Mitigation Info/Possible Solution			Severity Score: 10
			Field Measurements/Component Compliance

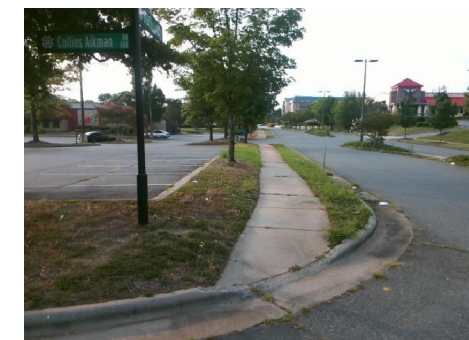
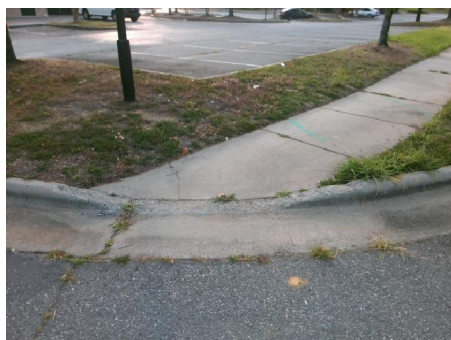
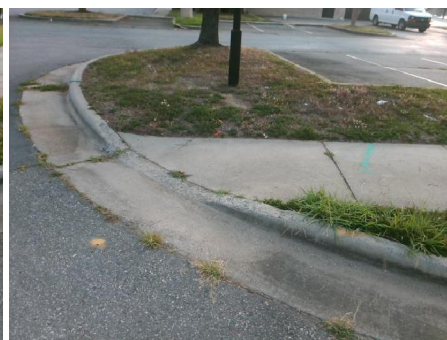
CRACK LT FL

R304.5.1, R304.5.3

Compliance	Description	Data	Compliance	Description	Data
N/A	Ramp Length (in)	35.0	N/A	Grade Break?	N/A
No	Ramp Width (in)	44.0	N/A	Grade Break Slope (%)	0.0
Yes	Ramp Slope (%)	6.7	N/A	Grade Break XSlope (%)	0.0
No	Ramp XSlope (%)	2.9			
N/A	Flare Type LT	N/A	N/A	Flare Type RT	N/A
N/A	Flare Slope LT (%)	N/A	N/A	Flare Slope RT (%)	0.0
N/A	Flare Traversable LT?	N/A	N/A	Flare Traversable RT?	N/A
N/A	Landing Length (in)	0.0	N/A	DWS Provided?	N/A
N/A	Landing Width (in)	0.0	N/A	DWS Contrast?	N/A
N/A	Landing Slope (%)	0.0	N/A	DWS Length (in)	N/A
N/A	Landing X Slope (%)	0.0	N/A	DWS Full Width?	N/A
N/A	Landing Curb? (Y/N)	N/A	N/A	DWS Offset LT (in)	N/A
N/A	Shared Landing?	N/A	N/A	DWS Offset RT (in)	N/A
N/A	Gutter Ponding?	0.0	N/A	Gutter Slope (%)	N/A
N/A	Gutter Lip Ht (in)	0.0	N/A	Gutter X Slope (%)	N/A
N/A	Painted X Walk1?	No		Road Slope (%)	0.3
	X Walk 1 Direction	To SW		Road X Slope (%)	1.0
	X Walk 1 Width (in)	N/A		Clear Space?	N/A

X Walk 1 Slope (%)	0.3	N/A	Clear Space to XWalk (in)	N/A
	X Walk 1 X Slope (%)	1.0	N/A	Storm Grate/Utility Hazard?	N/A
N/A	Ramp inside XWalk1?	N/A		Storm Grate/Utility Type	
N/A	Any Obstructions?	N/A			N/A
	Obstruction Type		Yes	Surface Condition? (G/P)	Good
			N/A	Curb Slope (%)	20.3

Remove & Replace Entire Ramp.
