Access Compliance Report

Public Rights-of-Way

(Curb Ramps)

Intersection ID: 10037212	Main Street: SANDY_ROCK_PL	Cross Street: N/A	Location:	E
ADA ID: 77E1B8F6C682	Ramp Type: Perp	Initial Pass/Fail: Pass	Overall Compliance: No	Severity Score: 0

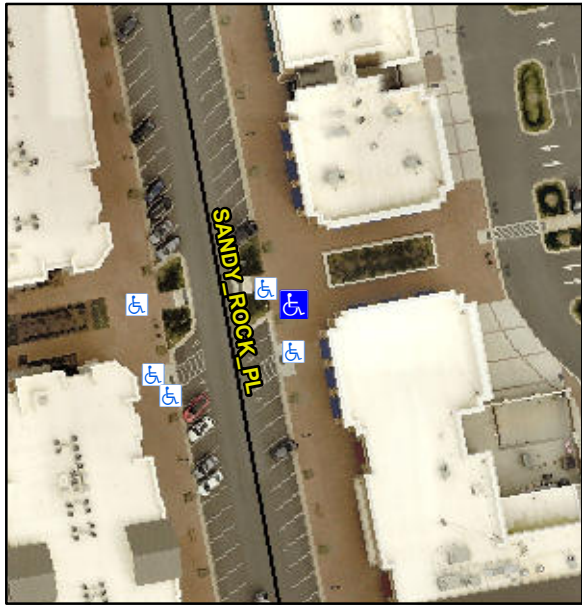
Possible Solutions:		Compliance			Description			Data	
	Remove & Replace Gutter.		N/A	Ramp Length (in)	84.5	Yes	Ramp Slope (%)	6.7		
			Yes	Ramp Width (in)	59.5	Yes	Ramp XSlope (%)	0.8		
			N/A	Flare Type LT	Sloped	N/A	Flare Type RT	N/A		
			N/A	Flare Slope LT (%)	7.7	Yes	Flare Slope RT (%)	5.5		
			N/A	Flare Traversable LT?	Yes	N/A	Flare Traversable RT?	Yes		
			Yes	Landing Length (in)	60.0	Yes	DWS Provided?	Yes		
			Yes	Landing Width (in)	60.0	Yes	DWS Contrast?	Yes		
			Yes	Landing Slope (%)	0.5	Yes	DWS Length (in)	24.0		
			Yes	Landing X Slope (%)	1.8	Yes	DWS Full Width?	Yes		
Surveyor Notes:		N/A			N/A	Landing Curb? (Y/N)	No	Yes	DWS Offset (in)	1.0
PROW/ADA:		R304.5.3			N/A	Shared Landing?	No			
		Yes	Gutter Ponding?	No	Yes	Gutter Slope (%)	3.1			
		Yes	Gutter Lip Ht (in)	0.0	No	Gutter X Slope (%)	2.9			
		N/A	Painted X Walk1?	No	N/A	Painted X Walk2?	N/A

X Walk 1 Direction	To W		X Walk 2 Direction	N/A			
		N/A	X Walk 1 Width (in)	N/A	N/A	X Walk 2 Width (in)	N/A			
			X Walk 1 Slope (%)	1.8		X Walk 2 Slope (%)	N/A			
			X Walk 1 X Slope (%)	1.5		X Walk 2 X Slope (%)	N/A			
		N/A	Ramp inside XWalk1?	N/A	N/A	Ramp inside XWalk2?	N/A			
			Road Slope (%)	N/A	N/A	Clear Space?	Yes			
			Road X Slope (%)	N/A	N/A	Clear Space to XWalk (in)	N/A			
		Yes	Any Obstructions?	No	Yes	Storm Grate/Utility Hazard?	No			
			Obstruction Type			Storm Grate/Utility Type				
					N/A		N/A			
					Yes	Surface Condition? (G/P)	Good			
Total Cost:		\$ 750.00
