# Access Compliance Report

## Public Rights-of-Way

### (Curb Ramps)

| Intersection ID: N/A | Main Street: W_T_HARRIS_BV | Cross Street: DELTA_CROSSING_LN | Location: NW |

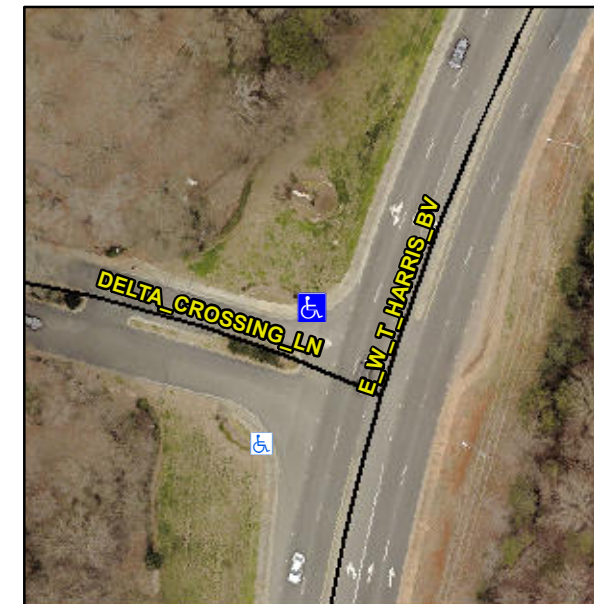
| ADA ID: 77E3FE35B01A | Ramp Type: PerpDiag | Initial Pass/Fail: Fail | Overall Compliance: No |

| Compliance | Description | Data | Compliance | Description | Data |
|---|---|---|---|---|---|
| N/A | Ramp Length (in) | 60.0 | No | Ramp Slope (%) | 10.6 |
| No | Ramp Width (in) | 39.0 | Yes | Ramp XSlope (%) | 0.7 |

**Remove & Replace Curb Ramp With Two New Directional Ramps or Equivalent.**

**R304.5.1, R304.2.2**
