Access Compliance Report

Public Rights-of-Way

(Curb Ramps)

Intersection ID: 15737	Main Street: HUNTLEY_PL	Cross Street: PROVIDENCE_RD	Location: SE
ADA ID: 77EC43B7862C	Ramp Type: PerpDiag	Initial Pass/Fail: Fail	Overall Compliance: No
Severity Score: 8.75			
Codes/Mitigation Info/Possible Solution		Field Measurements/Component Compliance

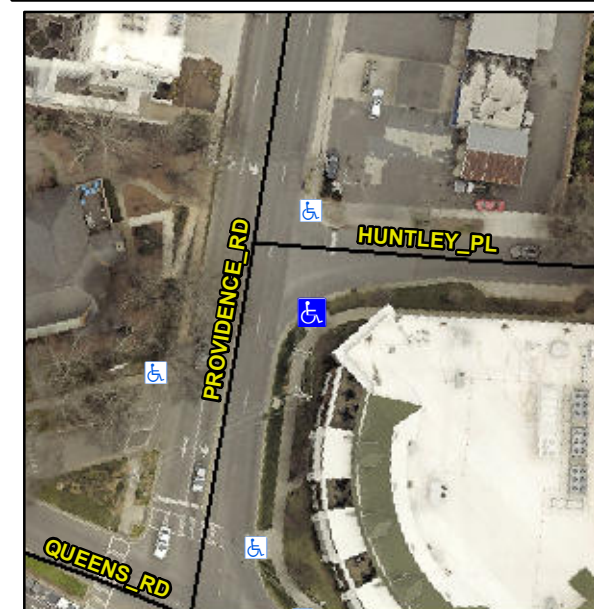
Not Found, R304.5.1

Compliance	Description	Data	Compliance	Description	Data
N/A	Ramp Length (in)	95.0	Yes	Ramp Slope (%)	6.2
No	Ramp Width (in)	47.0	Yes	Ramp XSlope (%)	0.4
N/A	Flare Type LT	N/A	N/A	Flare Type RT	N/A
N/A	Flare Slope LT (%)	N/A	N/A	Flare Slope RT (%)	N/A
N/A	Flare Traversable LT?	N/A	N/A	Flare Traversable RT?	N/A
N/A	Landing Length (in)	N/A	N/A	DWS Provided?	N/A
N/A	Landing Width (in)	N/A	N/A	DWS Contrast?	N/A
N/A	Landing Slope (%)	N/A	N/A	DWS Length (in)	N/A
N/A	Landing X Slope (%)	N/A	N/A	DWS Full Width?	N/A
N/A	Landing Curb? (Y/N)	N/A	N/A	DWS Offset (in)	N/A
N/A	Shared Landing?	N/A			
N/A	Gutter Ponding?	N/A	N/A	Gutter Slope (%)	N/A
N/A	Gutter Lip Ht (in)	N/A	N/A	Gutter X Slope (%)	N/A
N/A	Painted X Walk1?	No	N/A	Painted X Walk2?	No
	X Walk 1 Direction	To NE		X Walk 2 Direction	To NW
N/A	X Walk 1 Width (in)	N/A	N/A	X Walk 2 Width (in)	N/A
	X Walk 1 Slope (%)	2.3		X Walk 2 Slope (%)	1.0
	X Walk 1 X Slope (%)	0.5		X Walk 2 X Slope (%)	0.5

N/A	Ramp inside XWalk1?	N/A	N/A	Ramp inside XWalk2?	N/A
	Road Slope (%)	1.3	N/A	Clear Space?	N/A
	Road X Slope (%)	3.0	N/A	Clear Space to XWalk (in)	N/A
N/A	Any Obstructions?	N/A	N/A	Storm Grate/Utility Hazard?	N/A
	Obstruction Type			Storm Grate/Utility Type	
		N/A			N/A
			Yes	Surface Condition? (G/P)	Good

Possible Solutions:

Remove & Replace Curb Ramp With Two New Directional Ramps or Equivalent.
