Access Compliance Report

Public Rights-of-Way

(Curb Ramps)

Intersection ID: 5885	Main Street: ADONIS_CT	Cross Street: HELLEBORE_RD	Location: NW
ADA ID: 77F9A6D28F5C	Ramp Type: Perp	Initial Pass/Fail: Fail	Overall Compliance: No
Severity Score: 12.5			
Codes/Mitigation Info/Possible Solution		Field Measurements/Component Compliance

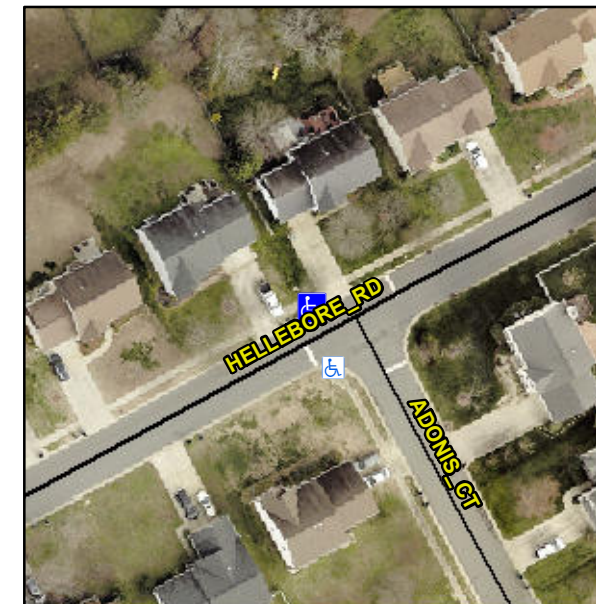
Not Found, R304.2.2

Compliance	Description	Data	Compliance	Description	Data
N/A	Ramp Length (in)	48.0	No	Ramp Slope (%)	10.8
Yes	Ramp Width (in)	48.0	Yes	Ramp XSlope (%)	1.6
N/A	Flare Type LT	N/A	N/A	Flare Type RT	N/A
N/A	Flare Slope LT (%)	N/A	N/A	Flare Slope RT (%)	N/A
N/A	Flare Traversable LT?	N/A	N/A	Flare Traversable RT?	N/A
N/A	Landing Length (in)	N/A	N/A	DWS Provided?	N/A
N/A	Landing Width (in)	N/A	N/A	DWS Contrast?	N/A
N/A	Landing Slope (%)	N/A	N/A	DWS Length (in)	N/A
N/A	Landing X Slope (%)	N/A	N/A	DWS Full Width?	N/A
N/A	Landing Curb? (Y/N)	N/A	N/A	DWS Offset (in)	N/A
N/A	Shared Landing?	N/A			
N/A	Gutter Ponding?	N/A	N/A	Gutter Slope (%)	N/A
N/A	Gutter Lip Ht (in)	N/A	N/A	Gutter X Slope (%)	N/A
N/A	Painted X Walk1?	No	N/A	Painted X Walk2?	N/A
	X Walk 1 Direction	To S		X Walk 2 Direction	N/A
N/A	X Walk 1 Width (in)	N/A	N/A	X Walk 2 Width (in)	N/A
	X Walk 1 Slope (%)	6.5		X Walk 2 Slope (%)	N/A
	X Walk 1 X Slope (%)	0.2		X Walk 2 X Slope (%)	N/A

N/A	Ramp inside XWalk1?	N/A	N/A	Ramp inside XWalk2?	N/A
	Road Slope (%)	N/A	N/A	Clear Space?	N/A
	Road X Slope (%)	N/A	N/A	Clear Space to XWalk (in)	N/A
N/A	Any Obstructions?	N/A	N/A	Storm Grate/Utility Hazard?	N/A
	Obstruction Type			Storm Grate/Utility Type	
		N/A			N/A
			Yes	Surface Condition? (G/P)	Good

Possible Solutions:

Remove & Replace Entire Ramp.
