# Access Compliance Report

## Public Rights-of-Way

### (Curb Ramps)

Intersection ID: 3027	Main Street: BROWNE_RD	Cross Street: AMBER_GLEN_DR	Location: W
ADA ID: 77FB14445CDD	Ramp Type: BlendTrans2	Initial Pass/Fail: Fail	Overall Compliance: No
		Severity Score: 25

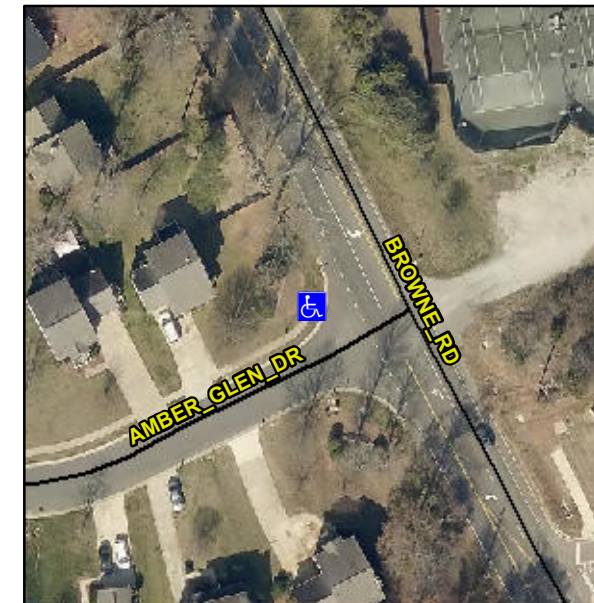
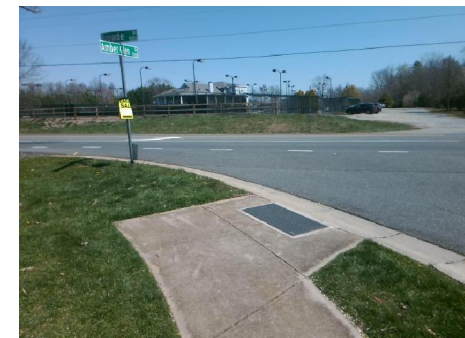
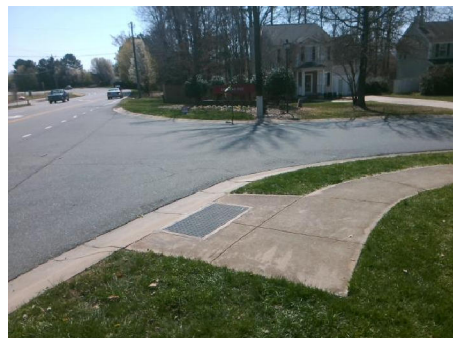
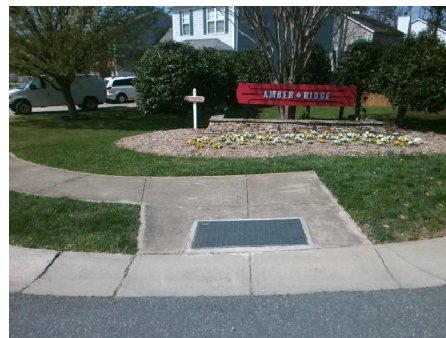
**Not Found, R304.5.3**

Compliance	Description	Data	Compliance	Description	Data
N/A	Ramp Length (in)	96.0	Yes	BlendTrans Slope (%)	2.2
Yes	Ramp Width (in)	95.0	No	BlendTrans XSlope (%)	7.3
N/A	Flare Type LT	N/A	N/A	Flare Type RT	N/A
N/A	Flare Slope LT (%)	N/A	N/A	Flare Slope RT (%)	N/A
N/A	Flare Traversable LT?	N/A	N/A	Flare Traversable RT?	N/A
N/A	Landing Length (in)	N/A	N/A	DWS Provided?	N/A
N/A	Landing Width (in)	N/A	N/A	DWS Contrast?	N/A
N/A	Landing Slope (%)	N/A	N/A	DWS Length (in)	N/A
N/A	Landing X Slope (%)	N/A	N/A	DWS Full Width?	N/A
N/A	Landing Curb? (Y/N)	N/A	N/A	DWS Offset (in)	N/A
N/A	Shared Landing?	N/A			
N/A	Gutter Ponding?	N/A	N/A	Gutter Slope (%)	N/A
N/A	Gutter Lip Ht (in)	N/A	N/A	Gutter X Slope (%)	N/A
N/A	Painted X Walk1?	No	N/A	Painted X Walk2?	No
	X Walk 1 Direction	To S		X Walk 2 Direction	To E
	X Walk 1 Width (in)	N/A		X Walk 2 Width (in)	N/A
	X Walk 1 Slope (%)	N/A		X Walk 2 Slope (%)	N/A
	X Walk 1 X Slope (%)	N/A		X Walk 2 X Slope (%)	N/A

N/A	Ramp inside XWalk1?	N/A	N/A	Ramp inside XWalk2?	N/A
	Road Slope (%)	3.1		Clear Space?	N/A
	Road X Slope (%)	3.6	N/A	Clear Space to XWalk (in)	N/A
N/A	Any Obstructions?	N/A	N/A	Storm Grate/Utility Hazard?	N/A
	Obstruction Type			Storm Grate/Utility Type	
		N/A			N/A
			Yes	Surface Condition? (G/P)	Good
			No	Curb Slope (%)	14.2

**Remove & Replace Curb Ramp With Two New Directional Ramps or Equivalent.**
