Access Compliance Report

Public Rights-of-Way

(Curb Ramps)

Intersection ID: N/A	Main Street: STATESVILLE_AV	Cross Street: ALMA_CT	Location: SW
ADA ID: 7801331A346B	Ramp Type: Combination1Diag	Initial Pass/Fail: Fail	Overall Compliance: No
Severity Score: 0			
Codes/Mitigation Info/Possible Solution		Field Measurements/Component Compliance

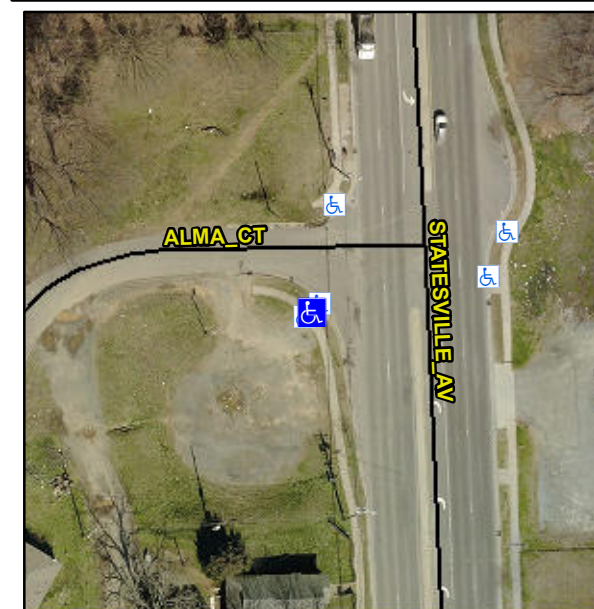
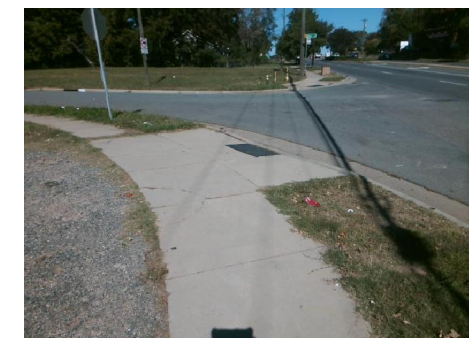
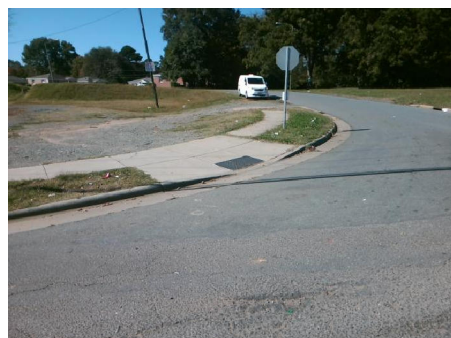
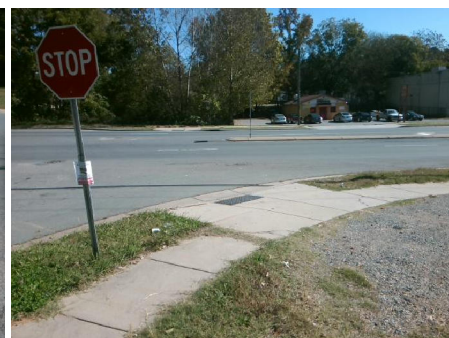
Not Found, R304.5.1, R304.2.2, R304.5.3

Compliance	Description	Data	Compliance	Description	Data
N/A	Ramp Length LT (in)	58.0	N/A	Ramp Length RT (in)	60.0
Yes	Ramp Width LT (in)	59.5	Yes	Ramp Width RT (in)	59.0
Yes	Ramp Slope LT (%)	5.0	Yes	Ramp Slope RT (%)	7.1
No	Ramp XSlope LT (%)	2.7	No	Ramp XSlope RT (%)	2.7
N/A	Ramp Length (in)	59.0	No	Ramp Slope (%)	8.7
No	Ramp Width (in)	43.0	No	Ramp XSlope (%)	4.7
N/A	Flare Type LT	N/A	N/A	Flare Type RT	N/A
N/A	Flare Slope LT (%)	N/A	N/A	Flare Slope RT (%)	N/A
N/A	Flare Traversable LT?	N/A	N/A	Flare Traversable RT?	N/A
N/A	Landing Length (in)	N/A	N/A	DWS Provided?	N/A
N/A	Landing Width (in)	N/A	N/A	DWS Contrast?	N/A
N/A	Landing Slope (%)	N/A	N/A	DWS Length (in)	N/A
N/A	Landing X Slope (%)	N/A	N/A	DWS Full Width?	N/A
N/A	Landing Curb? (Y/N)	N/A	N/A	DWS Offset (in)	N/A
N/A	Shared Landing?	N/A			
N/A	Gutter Ponding?	N/A	N/A	Gutter Slope (%)	N/A
N/A	Gutter Lip Ht (in)	N/A	N/A	Gutter X Slope (%)	N/A
N/A	Painted X Walk1?	No	N/A	Painted X Walk2?	No

X Walk 1 Direction	To E		X Walk 2 Direction	To N
	X Walk 1 Width (in)	N/A		X Walk 2 Width (in)	N/A
	X Walk 1 Slope (%)	0.2		X Walk 2 Slope (%)	4.1
	X Walk 1 X Slope (%)	4.8		X Walk 2 X Slope (%)	2.0
N/A	Ramp inside XWalk1?	N/A	N/A	Ramp inside XWalk2?	N/A
	Road Slope (%)	5.0		Clear Space?	N/A
	Road X Slope (%)	3.1	N/A	Clear Space to XWalk (in)	N/A
			N/A	Any Obstruction?	N/A
				Obstruction Type	N/A
			N/A	Storm Grate/Utility Hazard?	N/A
				Storm Grate/Utility Type	N/A
			Yes	Surface Condition? (G/P)	Good
				Curb Slope (%)	6.2

Remove & Replace Curb Ramp With Two New Directional Ramps or Equivalent.
