Access Compliance Report

Public Rights-of-Way

(Curb Ramps)

Intersection ID: N/A	Main Street: PROVIDENCE_COUNTRY_CLUB_DR	Cross Street: SOUTHMORE_DR	Location: NW
ADA ID: 780D700647E9	Ramp Type: PerpDiag	Initial Pass/Fail: Fail	Overall Compliance: No
Severity Score: 12.5			
Codes/Mitigation Info/Possible Solution		Field Measurements/Component Compliance

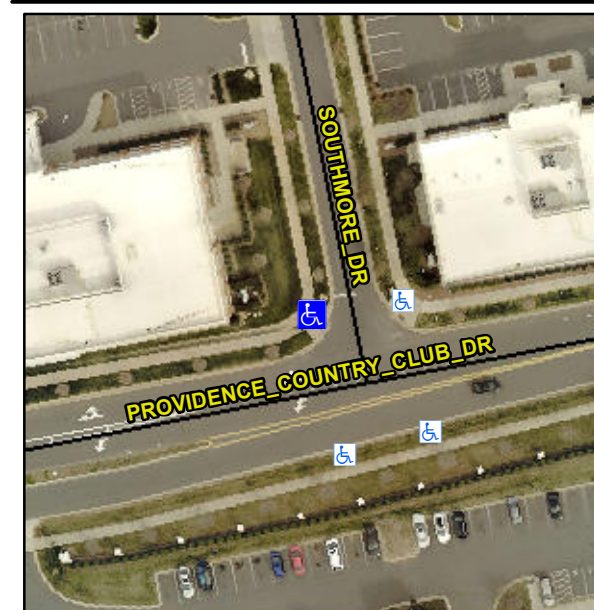
Compliance	Description	Data	Compliance	Description	Data
N/A	Ramp Length (in)	97.0	No	Ramp Slope (%)	8.6
Yes	Ramp Width (in)	48.0	Yes	Ramp XSlope (%)	0.6
N/A	Flare Type LT	N/A	N/A	Flare Type RT	N/A
N/A	Flare Slope LT (%)	N/A	N/A	Flare Slope RT (%)	N/A
N/A	Flare Traversable LT?	N/A	N/A	Flare Traversable RT?	N/A
N/A	Landing Length (in)	N/A	N/A	DWS Provided?	N/A
N/A	Landing Width (in)	N/A	N/A	DWS Contrast?	N/A
N/A	Landing Slope (%)	N/A	N/A	DWS Length (in)	N/A
N/A	Landing X Slope (%)	N/A	N/A	DWS Full Width?	N/A
N/A	Landing Curb? (Y/N)	N/A	N/A	DWS Offset (in)	N/A
N/A	Shared Landing?	N/A			
N/A	Gutter Ponding?	N/A	N/A	Gutter Slope (%)	N/A
N/A	Gutter Lip Ht (in)	N/A	N/A	Gutter X Slope (%)	N/A
N/A	Painted X Walk1?	No	N/A	Painted X Walk2?	No
	X Walk 1 Direction	To S		X Walk 2 Direction	To E
N/A	X Walk 1 Width (in)	N/A	N/A	X Walk 2 Width (in)	N/A
	X Walk 1 Slope (%)	1.7		X Walk 2 Slope (%)	0.8
	X Walk 1 X Slope (%)	1.6		X Walk 2 X Slope (%)	1.3

N/A	Ramp inside XWalk1?	N/A	N/A	Ramp inside XWalk2?	N/A
	Road Slope (%)	0.1	N/A	Clear Space?	N/A
	Road X Slope (%)	1.2	N/A	Clear Space to XWalk (in)	N/A
N/A	Any Obstructions?	N/A	N/A	Storm Grate/Utility Hazard?	N/A
	Obstruction Type			Storm Grate/Utility Type	
		N/A			N/A
		Yes		Surface Condition? (G/P)	Good

Possible Solutions:

Remove & Replace Curb Ramp With Two New Directional Ramps or Equivalent.

R304.2.2

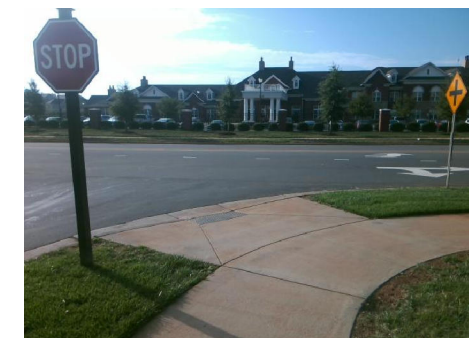
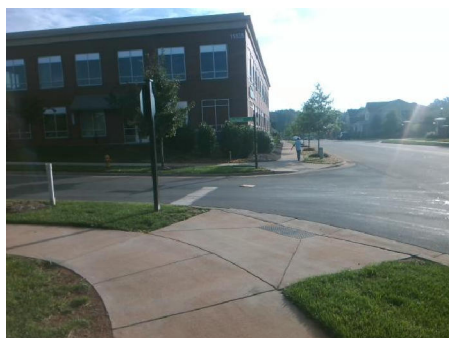
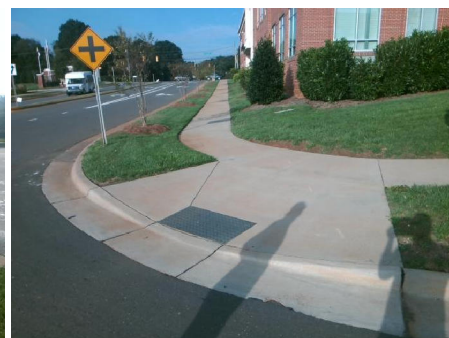
Street 1 Name **PROVIDENCE COUNTRY CLUB DR**
 Stop Condition-Street 2 **None**
 Street 2 Name **SOUTHMORE DR**
 Stop Condition-Street 1 **StopSign**
