Access Compliance Report

Public Rights-of-Way

(Curb Ramps)

Intersection ID: 50401	Main Street: DEBORAH_DR	Cross Street: WILSON_DR	Location: S
ADA ID: 7810A19FEAB5	Ramp Type: Perp	Initial Pass/Fail: Fail	Overall Compliance: No
Severity Score: 1.25			
Codes/Mitigation Info/Possible Solution		Field Measurements/Component Compliance

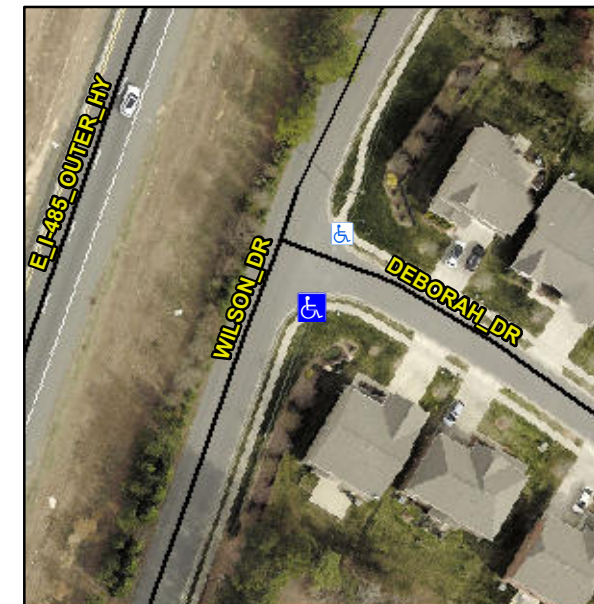
Not Found, R304.5.3

Compliance	Description	Data	Compliance	Description	Data
N/A	Ramp Length (in)	78.0	Yes	Ramp Slope (%)	7.9
Yes	Ramp Width (in)	48.0	No	Ramp XSlope (%)	2.9
N/A	Flare Type LT	N/A	N/A	Flare Type RT	N/A
N/A	Flare Slope LT (%)	N/A	N/A	Flare Slope RT (%)	N/A
N/A	Flare Traversable LT?	N/A	N/A	Flare Traversable RT?	N/A
N/A	Landing Length (in)	N/A	N/A	DWS Provided?	N/A
N/A	Landing Width (in)	N/A	N/A	DWS Contrast?	N/A
N/A	Landing Slope (%)	N/A	N/A	DWS Length (in)	N/A
N/A	Landing X Slope (%)	N/A	N/A	DWS Full Width?	N/A
N/A	Landing Curb? (Y/N)	N/A	N/A	DWS Offset (in)	N/A
N/A	Shared Landing?	N/A			
N/A	Gutter Ponding?	N/A	N/A	Gutter Slope (%)	N/A
N/A	Gutter Lip Ht (in)	N/A	N/A	Gutter X Slope (%)	N/A
N/A	Painted X Walk1?	No	N/A	Painted X Walk2?	N/A
	X Walk 1 Direction	To NE		X Walk 2 Direction	N/A
N/A	X Walk 1 Width (in)	N/A	N/A	X Walk 2 Width (in)	N/A
	X Walk 1 Slope (%)	0.0		X Walk 2 Slope (%)	N/A
	X Walk 1 X Slope (%)	1.7		X Walk 2 X Slope (%)	N/A

N/A	Ramp inside XWalk1?	N/A	N/A	Ramp inside XWalk2?	N/A
	Road Slope (%)	N/A	N/A	Clear Space?	N/A
	Road X Slope (%)	N/A	N/A	Clear Space to XWalk (in)	N/A
N/A	Any Obstructions?	N/A	N/A	Storm Grate/Utility Hazard?	N/A
	Obstruction Type			Storm Grate/Utility Type	
		N/A			N/A
		Yes		Surface Condition? (G/P)	Good

Remove & Replace Entire Ramp.

Total Cost: \$ 1850.00
