Access Compliance Report

Public Rights-of-Way

(Curb Ramps)

Intersection ID: 11941	Main Street: BELMONT_AV	Cross Street: N_ALEXANDER_ST	Location: S
ADA ID: 7817A863EE35	Ramp Type: BlendTrans2	Initial Pass/Fail: Fail	Overall Compliance: No
		Severity Score: 10

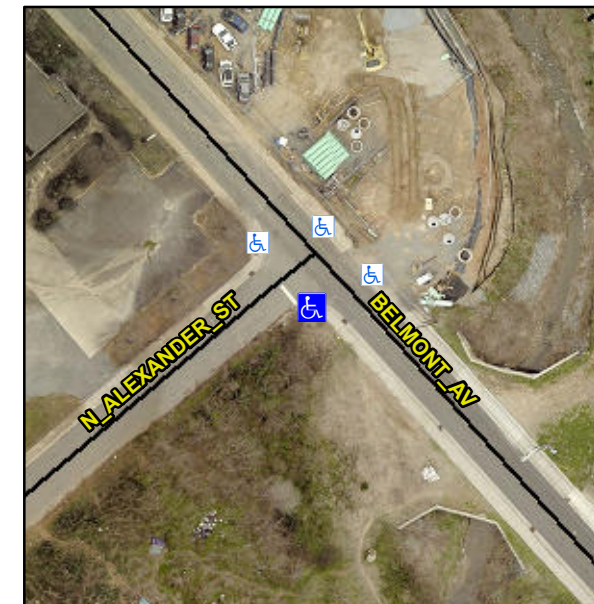
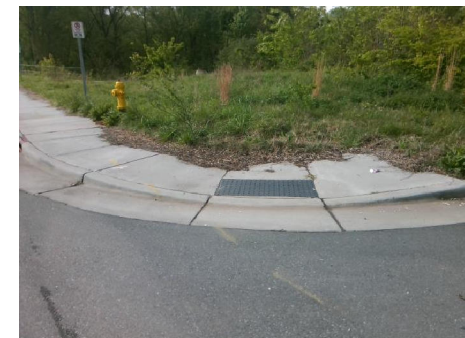
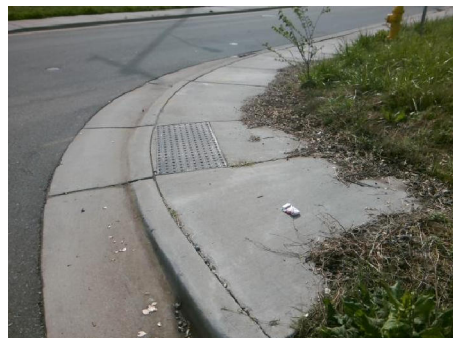
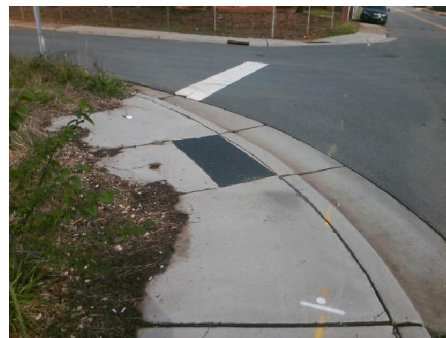
NO RT SW

Not Found, R304.5.1, R304.5.3

Compliance	Description	Data	Compliance	Description	Data
N/A	Ramp Length (in)	70.0	Yes	BlendTrans Slope (%)	0.5
No	Ramp Width (in)	44.0	No	BlendTrans XSlope (%)	4.6
N/A	Flare Type LT	N/A	N/A	Flare Type RT	N/A
N/A	Flare Slope LT (%)	N/A	N/A	Flare Slope RT (%)	N/A
N/A	Flare Traversable LT?	N/A	N/A	Flare Traversable RT?	N/A
N/A	Landing Length (in)	N/A	N/A	DWS Provided?	N/A
N/A	Landing Width (in)	N/A	N/A	DWS Contrast?	N/A
N/A	Landing Slope (%)	N/A	N/A	DWS Length (in)	N/A
N/A	Landing X Slope (%)	N/A	N/A	DWS Full Width?	N/A
N/A	Landing Curb? (Y/N)	N/A	N/A	DWS Offset (in)	N/A
N/A	Shared Landing?	N/A			
N/A	Gutter Ponding?	N/A	N/A	Gutter Slope (%)	N/A
N/A	Gutter Lip Ht (in)	N/A	N/A	Gutter X Slope (%)	N/A
N/A	Painted X Walk1?	No	N/A	Painted X Walk2?	No
	X Walk 1 Direction	To NE		X Walk 2 Direction	To NW
	X Walk 1 Width (in)	N/A		X Walk 2 Width (in)	N/A
	X Walk 1 Slope (%)	0.4		X Walk 2 Slope (%)	5.6
	X Walk 1 X Slope (%)	4.5		X Walk 2 X Slope (%)	2.1

N/A	Ramp inside XWalk1?	N/A	N/A	Ramp inside XWalk2?	N/A
	Road Slope (%)	4.0		Clear Space?	N/A
	Road X Slope (%)	2.5	N/A	Clear Space to XWalk (in)	N/A
N/A	Any Obstructions?	N/A	N/A	Storm Grate/Utility Hazard?	N/A
	Obstruction Type			Storm Grate/Utility Type	
		N/A			N/A
			Yes	Surface Condition? (G/P)	Good
			No	Curb Slope (%)	18.2

Remove & Replace Curb Ramp With Two New Directional Ramps or Equivalent.
